Analysis of Failed Teton Dam

Abstract—The failure of Teton Dam in Idaho in June, 1976, during the first filling of the reservoir, was a significant event for geotechnical engineers concerned with the design and construction of earth dams, simply because no dam of such a height (approximately 300 ft above stream bed) had previously failed. Thus the failure was both dramatic and of considerable importance. This paper reviews the events leading to the failure of Teton Dam to determine the cause of failure. Conclusions are presented regarding the probable trigger mechanisms which initiated the failure. In addition, an investigation of the area by geologist of the U.S. Geologic Survey indicated that it was seismically active: five earthquakes had occurred within 30 miles (50 km) of the dam site in the previous five years, two of which had been of significant magnitude. As it was a finite slope structure which failed during the first filling of the reservoir, therefore, in order to review the causes of failure, slope stability analysis of this dam profile has been done under structural stability, seepage and seismic analysis. The aforesaid analyses are accomplished using several methods

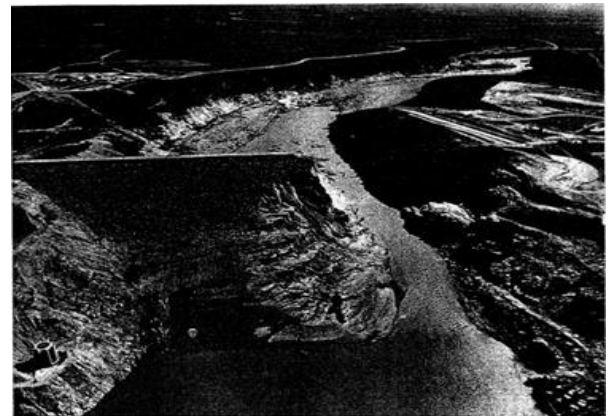
No plans have been made for rebuilding the Teton Dam, but its reconstruction has been brought up on at least one occasion. The original dam is the terraced, which is pyramidal in shaped monolith in the centre of the canyon in the centre of the photograph (Figures 1, 2) obtained from the [web link](http://www.geol.ucsb.edu/faculty/sylvester/Teton_Dam/narrative.pdf) [http://www.geol.ucsb.edu/faculty/sylvester/Teton Dam/narrative.pdf](http://www.geol.ucsb.edu/faculty/sylvester/Teton_Dam/narrative.pdf). The cut on the right was made after the failure to determine the structure of the embankment. Seed and Ducan (1982) investigated the possibility of sealing the

Figure 1: View of failed Teton dam

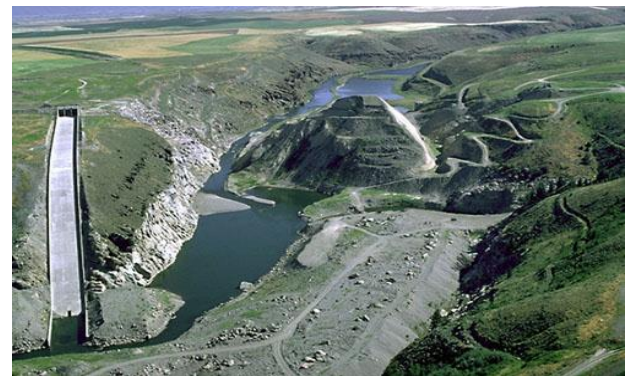
Figure 2: Present day (Photo by U.S. Bureau of Reclamation)

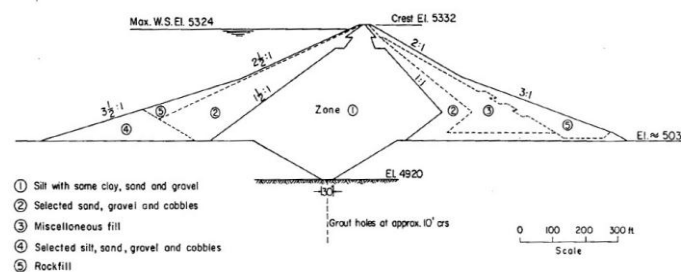
On the basis of the site exploration program, the final design of the embankment, Seed and Ducan (1981) had the configuration shown in figures 3 and 4. A wide core zone of the Aeoliansilt (upstream slope 1 on 1-1/2 and downstream 1 on 1) was supported by upstream and downstream shells consisting mainly of sand, gravel and cobbles. In the main section of the dam, the impervious core was extended through the foundations alluvium by means of a 100 ft. deep cut-off trench backfilled with the silt. On the abutments above El.5100, a similar section was adopted but key trenches with a base width of 30 ft. and side slopes of 1/2 on 1 were excavated through the upper 70 ft. of permeable rock and backfilled with the silty material used in the core of the dam.

Figure 3: Cross section through of centre portion of embankment founded on Alluvium

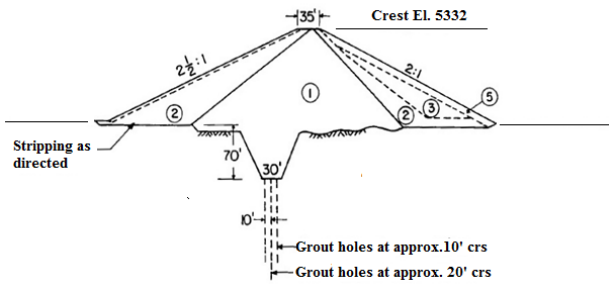
Figure 4: Typical cross section over abutment sections founded on jointed Rhyolite

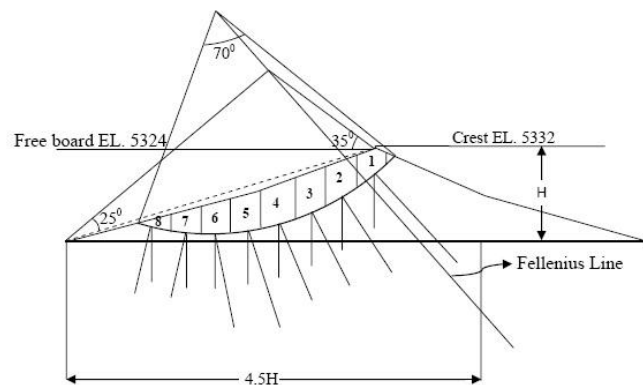
Figure 6: first trial failure surface by Fellenius method.

- Structural analyses carried out for all the three trials yield impressive values of Factor of Safety. It can be inferred that the Teton dam profile was structurally stable. Among all the trials, the fourth one has the greatest Factor of Safety rendering it to be the most stable, structurally.

- From Seepage analyses trial 1 and 2 indicate the failure due to seepage cause. As in trial 1 and 2, more no. of slices is under zone I, where the seepage force is maximum. At the same time trial 4 is stable because there is more no. of slices in it, and moreover greater weight to counteract the seepage force.

- From the seismic analysis of four trials, trial 1, 2, 3 show less stability in terms of their Factor of Safety values, because overall all the slices are at greater elevations. Greater elevation implies greater seismic coefficient thereby less Factor of Safety, but in trial 4 due to less average height of all the slices, there is less seismic coefficient and hence greater stability in terms of Factor of Safety.

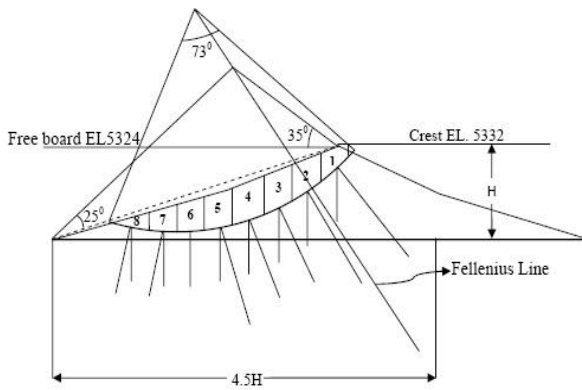
Figure 7: Second trial failure surface by Fellenius method.

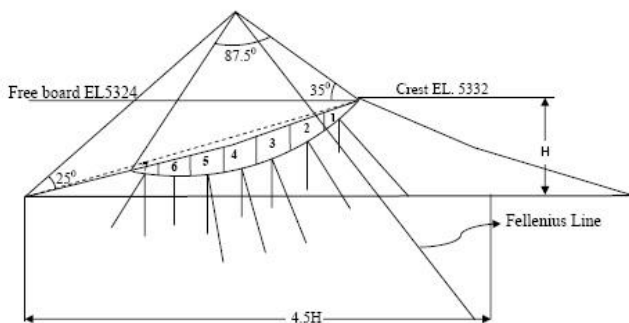
Figure 8: Third trial failure surface by Fellenius method.

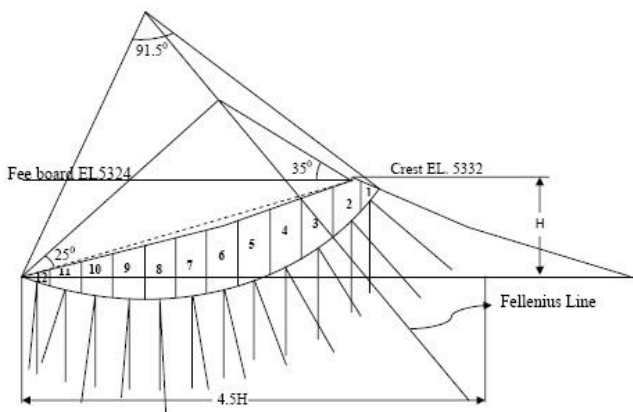
Figure 9: Fourth trial failure surface by Fellenius method.
