# Effects of Raw Material Surface Defects on High Strength Cr-Si Engine Valve Grade Spring Performance in Vehicle Operating Condition

Shivarama.K,  
Metallurgy Department,  
Stumpp Schuele and Somappa Springs Pvt Ltd.,  
#139, Hosur Road, Koramangala,  
Bangalore, Karnataka,India.

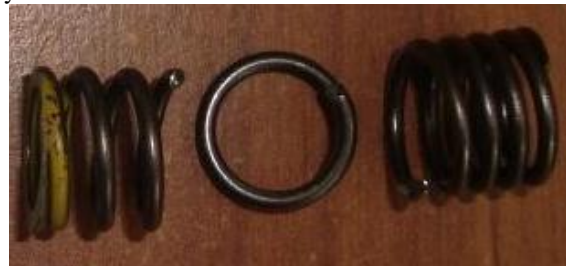
The as received condition of failed spring is as shown in fig 3. Detailed metallurgical investigations were carried out on the failed spring sample which included visual examination, stereo and metallurgical microscopy, scanning electron microscopy/EDS, and spectro analysis for chemical analysis.

Fig 3 As received photograph of failed spring

The spring was found to be broken at multiple locations viz. 3.75<sup>th</sup> and 5<sup>th</sup> coil from one of the spring as shown in fig 3. The fractures faces was cut from the broken spring and observed under stereo microscope at 10X magnification. The fracture face appears to be fatigue failure and the fatigue crack was found to be initiated from outer surface and further propagated, fig 4-5. At the crack initiation point, seam crack type surface defect was observed, see fig 4. Seam crack continues on the entire length of specimen and which appears to be originated from raw material. The shot peening coverage on the spring surface found to be uniform indicates the shot peening process during spring manufacturing was satisfactory, fig 6.

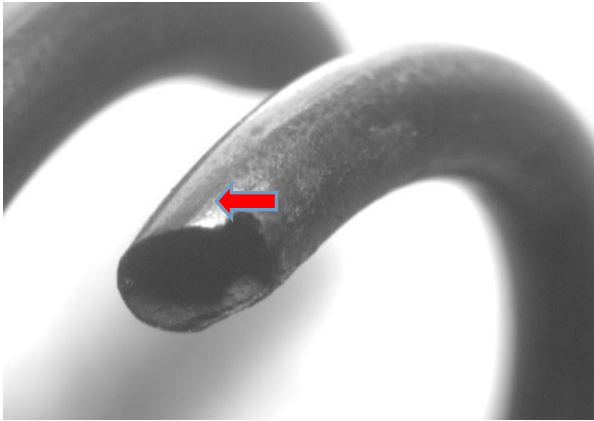
Fig. 4 Seam/lap type type surface defect

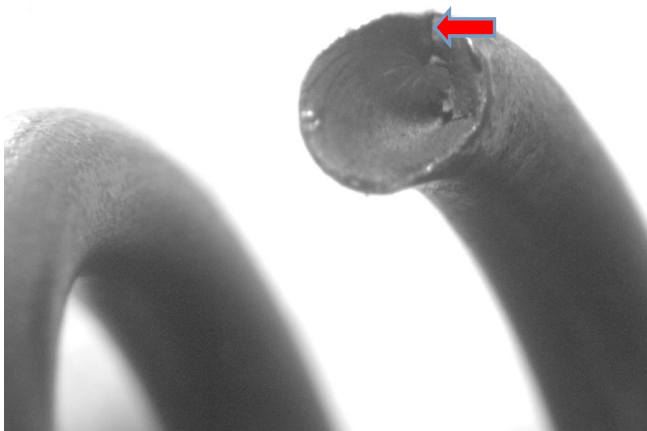
Fig. 5 Fatigue crack initiation from spring outer surface (10X)

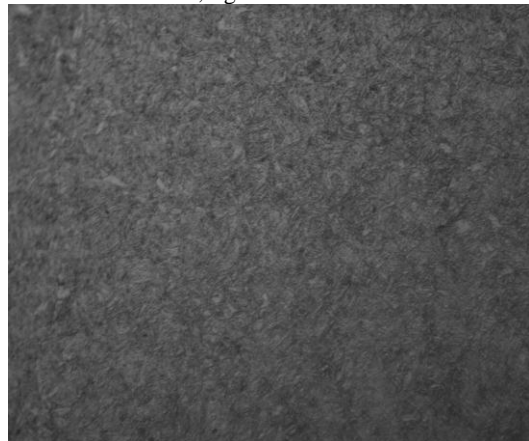
The cross sectional sample was cut near the fracture face of the failed spring, moulded, polished, etched and observed under metallurgical microscope at 100X and 500X magnifications. The microstructure reveals that tempered martensite, fig.7 with no significant decarburization, fig.8.

Fig 7 Tempered martensite (500X)

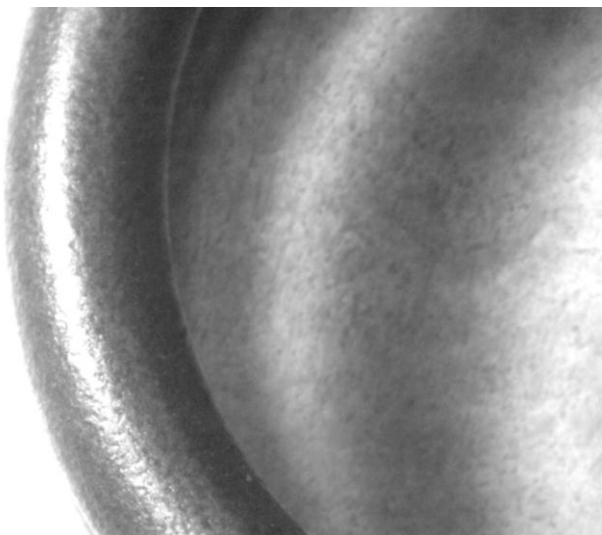
Fig 6 Good shot peening coverage on spring surface (10X)

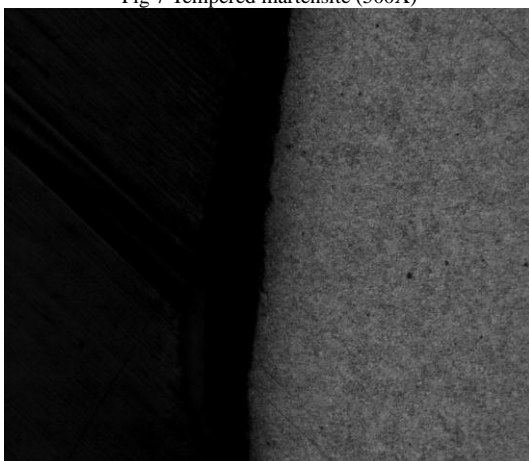
Fig 8 Nil decarburization (100X)

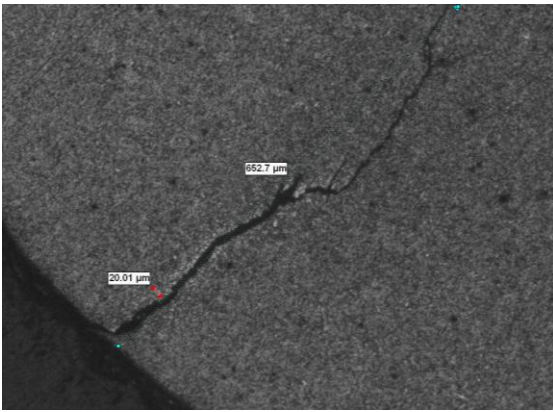
However, the cross sectional microstructure exhibits the presence of seam crack on the raw material used. About 652 microns seam crack depth was measured as shown in fig 9 and decarburization up to 20 microns around the seam crack was observed, which indicates the defect was carried from basic wire rod manufacturing and propagated further processes.

Fig 9 Seam crack and partial decarb (100X)

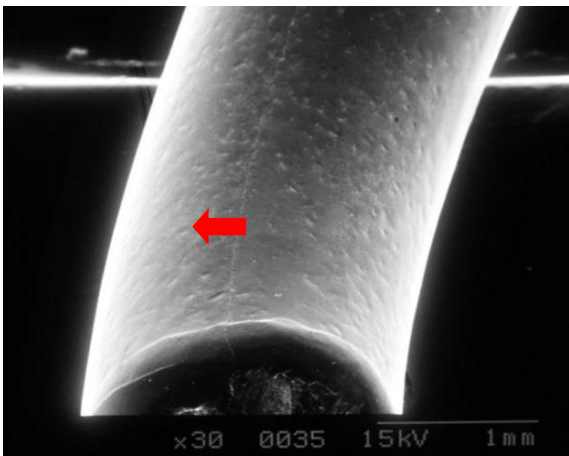
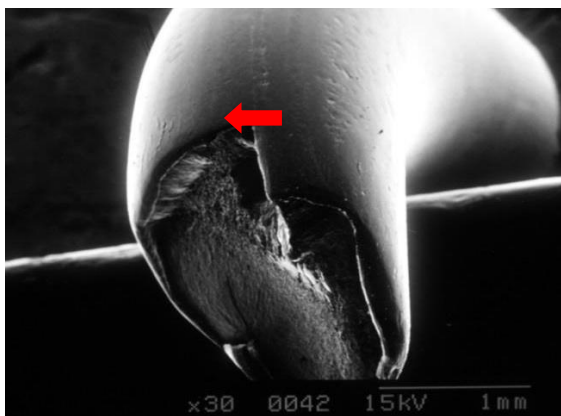
SEM images of fractured surface of failed spring are shown in fig. 10-11. Seam crack was observed at the origin of fatigue fracture and on wire surface of failed spring surface. Seam crack continues on the entire length of specimen.

Fig 10-11 SEM images of failed spring fracture surface.

B. The spring failure was occurred due to premature fatigue failure and the cause for the fatigue is presence of surface defect like seam crack on the surface of raw material used, which has acted stress raiser and fatigue crack has initiator, which was propagated further during heat treatment and cyclic loading condition in the vehicle engine assembly and caused premature fatigue failure.

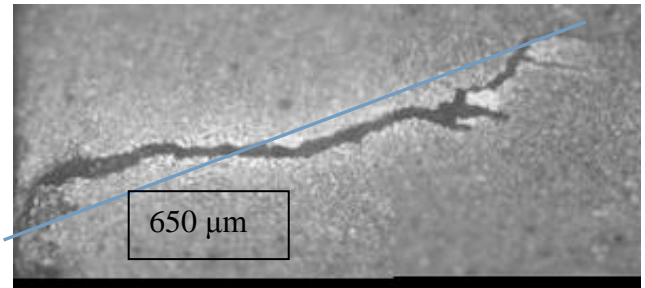
Spring cross section sample was also analyzed with SEM both near the fracture surface and the opposite side end as shown in fig. 12-13. The depth of seam crack was found to be about 650 μm. Decarburization was observed around the seam crack.

Fig.12 Seam crack and decarburization around crack at the fracture face

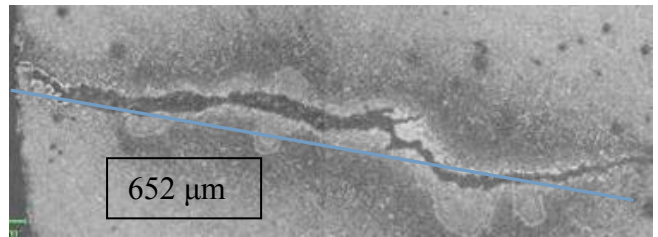
Fig.13 Seam crack and decarburization at the opposite end of the fracture face

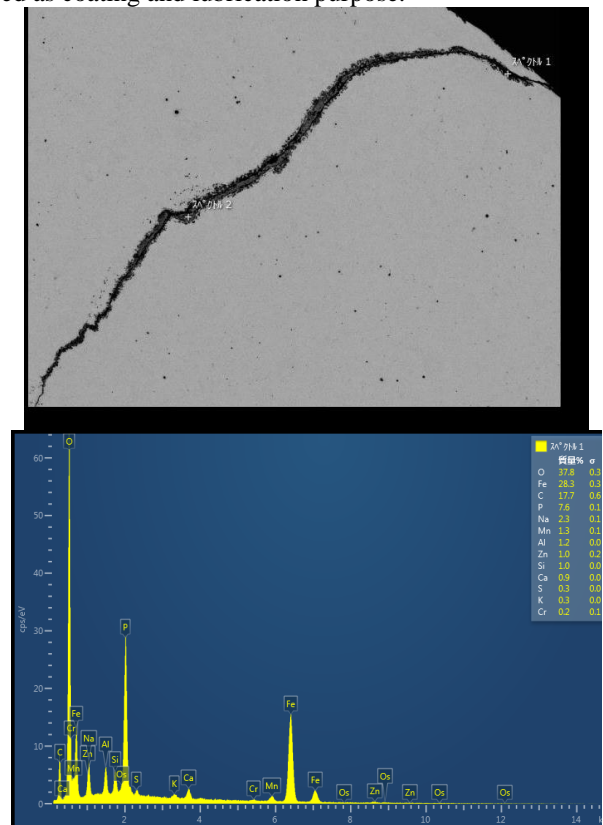
EDS analysis was carried out on the seam crack observed locations of failed spring. The result shows that, the presence of Calcium (Ca), Zinc (Zn) and Phosphorus (P) in addition to steel elements and Oxygen (O), fig. 13. The presence of elements like Ca, Zn and P, which could be carried from wire drawing process, where Zinc phosphate and Calcium being used as coating and lubrication purpose.

Fig.13 EDS analysis of failed spring near the fracture face.

D.As per EDS analysis results, Zinc, Calcium and Phosphorus were present on the seam crack portion, which was carried from wire drawing coating and lubricants used, which indicates that, the defect was preexisting and carried to final spring component. During cyclic loading in the application, the defect was further extended and caused failure.
