Failure Analysis of Tension Spring

Yogesh Mahajan, A. Y. Vyavahare, D. R. Peshwe
Department of Metallurgical and Materials Engineering,
Visvesvaraya National Institute of Technology,
Nagpur, Maharashtra, India

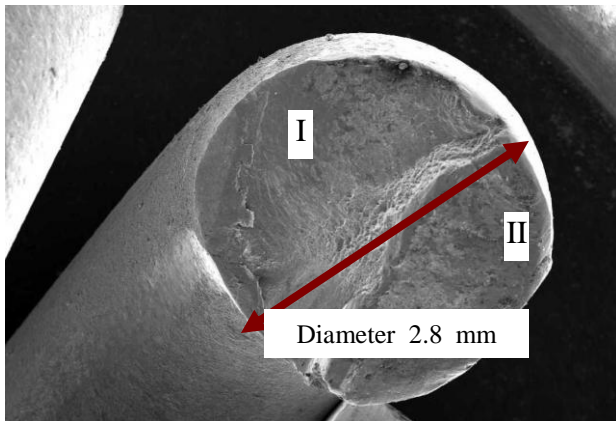
There were total three springs fractured, each into two parts. The wire diameter is measured and found to be as per the specification and also confirms to the Gr.III. Fig. 2 shows the fracture appearance of one spring with a wire diameter 2.8 mm. The upper and lower portions of the failed springs are analyzed separately.

Fig. 2 Appearance of spring fracture, Region I and II and diameter of the helical tension spring

Visual examination of the spring samples under the stereoscopic microscope at 20X magnification revealed a brittle surface. In all the three spring samples fracture occurs at the ends. The plane of fracture is from the maximum bending location. Also, the broken portions did not show any perceptible deformation in the region of cracking. Macroscopic investigation of normal spring supplied by the supplier doesn't reveal any surface abnormality and confirms to specification.

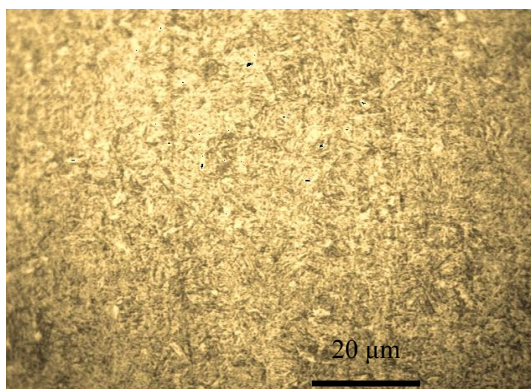
Microscopic investigation does not reveal any abnormality in the microstructure. It shows ferrite and pearlite phase typical of a low carbon unalloyed patented spring steel.

Fig. 3 Optical microstructure of low carbon unalloyed helical tension spring wire

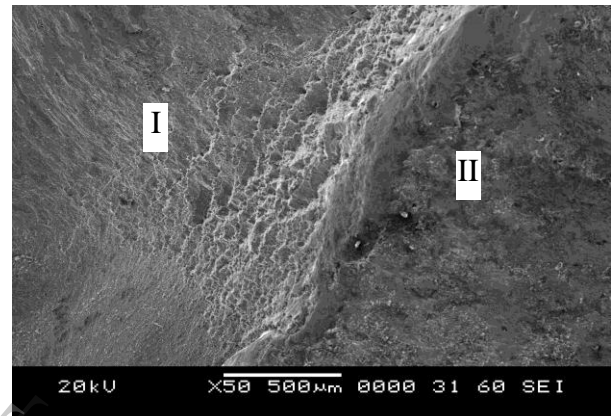
The fractures occurring in the tension spring are basically consistent with those opened artificially along the circumferential cracks. The fracture consists of two areas. Area I is even fracture, near the spring inner surface, while Area II is quite rough and has large height difference, called slanted fracture as can be seen from the SEM images no. 4, 5, and 6. Area I of the fractures accounts for about 65% of the spring cross section.

Fig. 4 Appearance of the helical tension spring fracture at X50

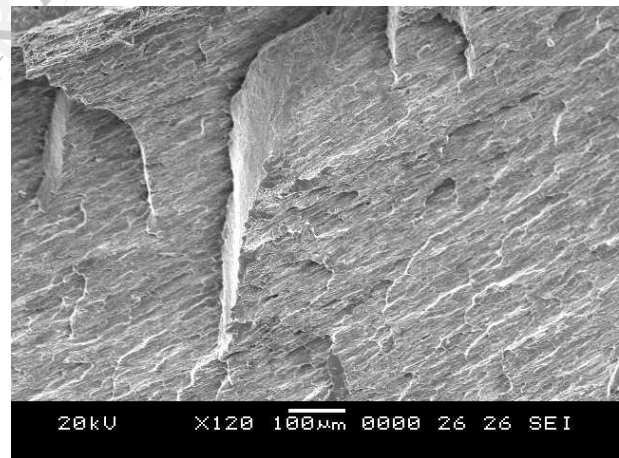
Fig. 5 Appearance of the helical tension spring fracture in area I

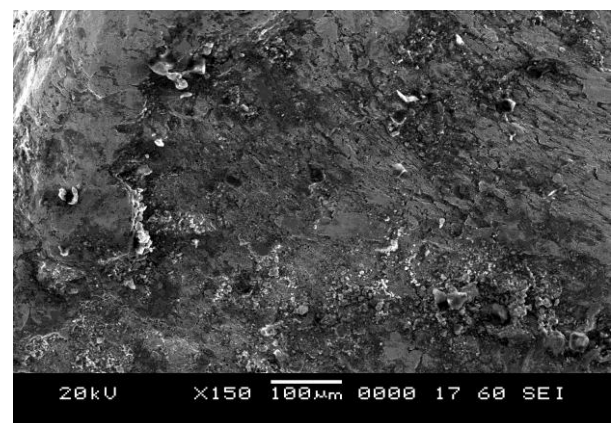
Fig. 6 Appearance of the helical tension spring fracture in area II

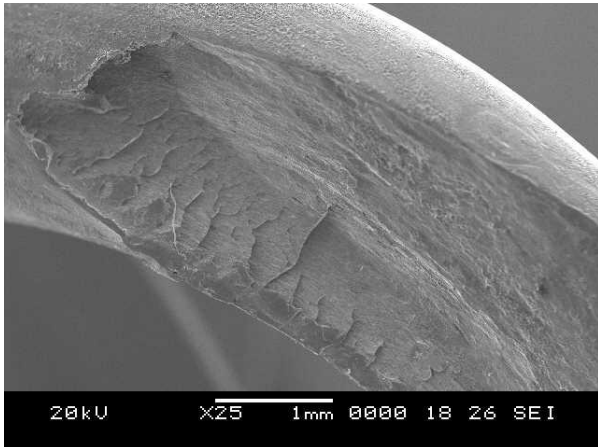
Observation of the helical tension spring is conducted by scanning electron microscopy (SEM). A series of SEM images of upper and lower part of the tension spring were taken. Fig. no 7 and 8 shows the full morphology of upper and lower fractured surface of a tension spring, respectively. Very little indication of ductile behavior during failure as revealed from its SEM appearance as indicated in Fig. no. 7 and 8.

Fig. 7 Fracture zone of the helical tension spring (Upper fractured portion/Hook side)

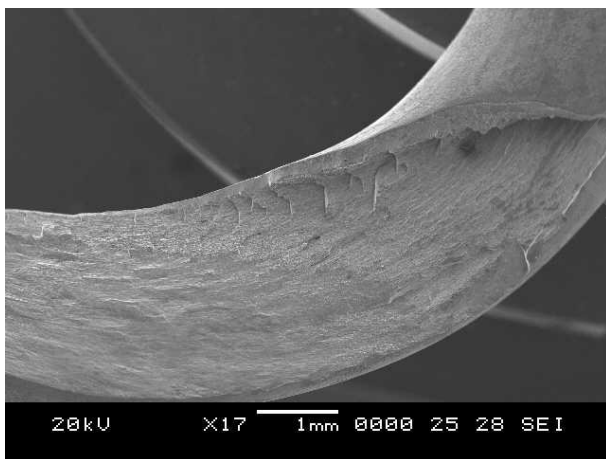
Fig. 8 Fracture zone of the helical tension spring (Lower fractured portion)

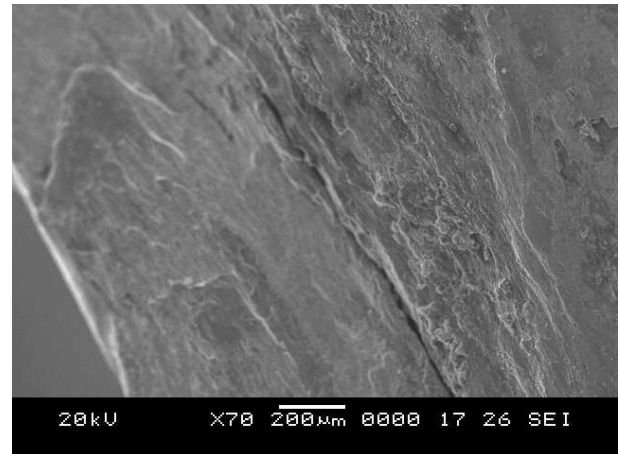
Fig. nos. 9 and 10 shows surface irregularities such as surface cracks, pits etc. at 70X magnification of upper and lower portion of the tension spring, respectively. After analyzing SEM images nos. 9 and 10, presence of outer surface crack are suggestive indications for the possible location for the start of failure.

Fig. 9 Surface irregularities on the outer surface of the helical tension spring (Upper fractured portion/Hook side)

Following precautions can minimize the chances of premature failure- 1. Stress relieving operations will minimize the failure. 2. Increasing stress relieving time will help in reducing the stress level and subsequent failure. 3. The elimination of above crack prone sites leads decrease in the failure in future. 4. Reducing surface irregularities will decrease the chances of failures.

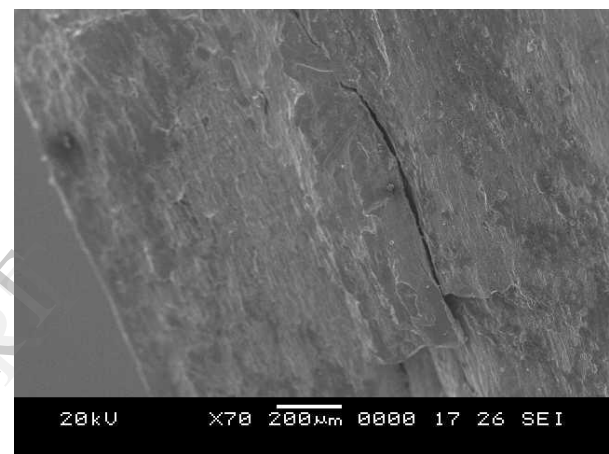
Fig. 10 Surface cracks on the outer surface of the helical tension spring near the fractured end (Lower fractured portion)

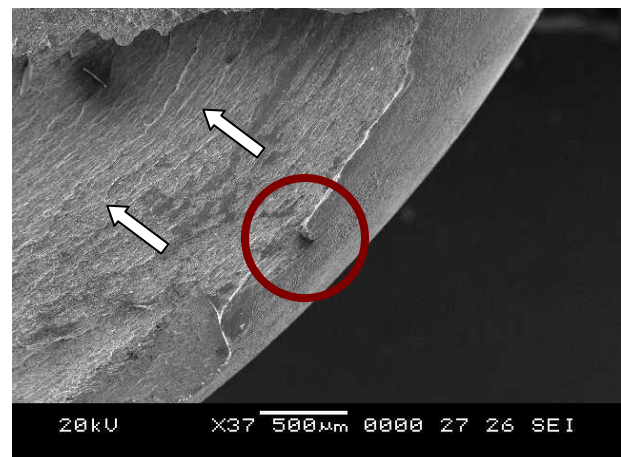
The suggestive indications are confirmed after analyzing SEM images nos. 11, 12, and 13 of the upper fractured surface of spring. A portion marked on the SEM image no. 11 is magnified and analyzed at higher magnification X140 and X350 gives a clear indication of the presence of surface crack of about 100-150 micron in depth from outer surface which is responsible for decreasing the effective cross sectional area of the steel wire.

Fig. 11 Fracture zone of the helical tension spring and direction of crack propagation The red marked area is further magnified in SEM images 12 and 13 (Upper fractured portion/Hook side)

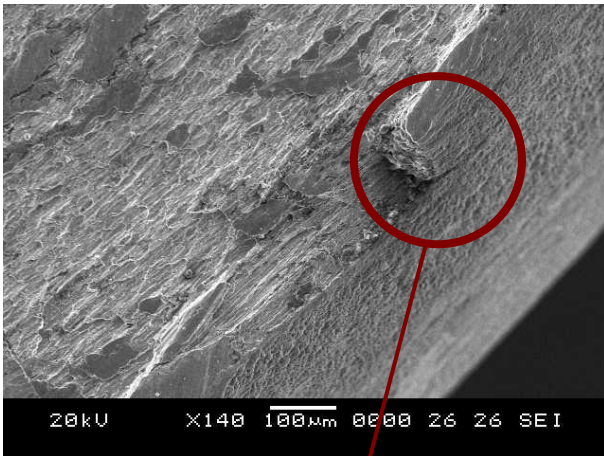
Fig. 12 Fracture zone of the helical tension spring (Upper fractured portion/Hook side)

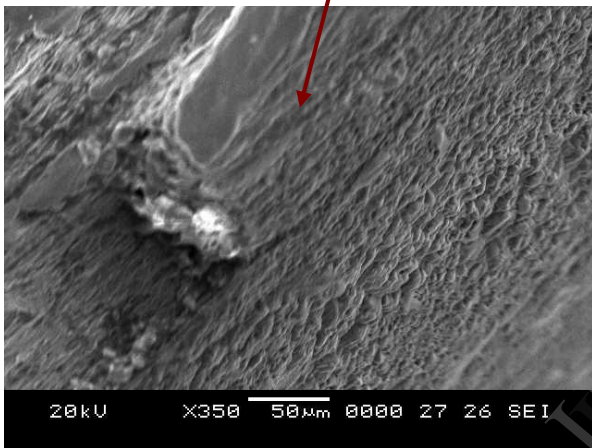
Fig. 13 Crack Morphology in the helical tension spring at X350 (Upper fractured portion/Hook side)

It can be seen from the visual observations that the tension spring fail from the hook portion. The plane of fracture is from the maximum bending location. Surface irregularities such as pits and surface cracks are present on the surfaces which are responsible for increasing the stress concentration sites. It can be seen in SEM images 11 to 13 that crack originated from the surface and travels inside. The depth of the crack is about 100-150 micron which reduces the effective cross sectional area of the spring, fig.14.
