# Failure Investigation for Input Shaft of Auxiliary Hoist Gear Box

Rahul S Korde  
Dr. D.Y. Patil School of Engineering  
Lohegaon Campus  
Pune, Maharashtra, India

Amol N Patil  
Dr. D.Y. Patil School of Engineering  
Lohegaon Campus  
Pune, Maharashtra, India

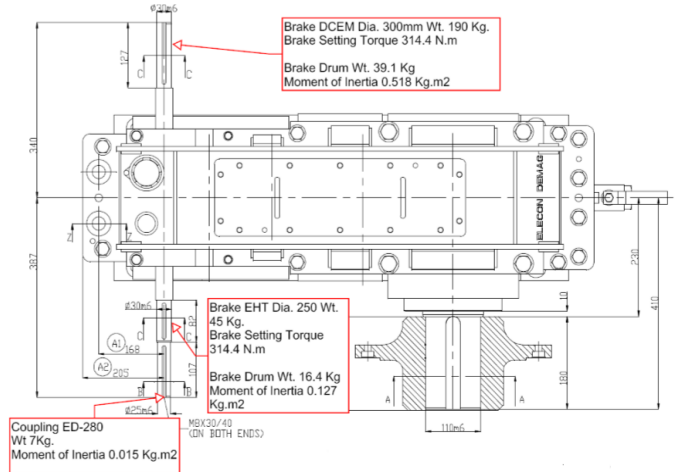
In this study, we have analysed input shaft of auxiliary hoist gear box which failed in the form of fracture after a year of operation. Material of shaft is as per DIN EN 10084 Grade 20MnCr5. As informed the shaft is in hardened and tempered condition. The teeth portion of the shaft is case carburized. The failure of shaft was seen during hoisting operation at the customer site and it was not going in upward direction. The crane was being operated in no load condition. So the maintenance team checked the gear box and it was found that the shaft had failed. The failure was seen at 50% production load. For this specific crane, the failure was noticed for first the time. The site photograph and drawing showing failed shaft are as given below:

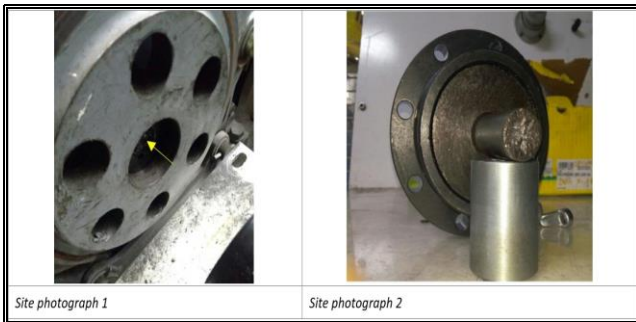
Plate: 1 Shows broken piece of input shaft of hoist gear box in as-received condition. The fracture region is in the marking area.

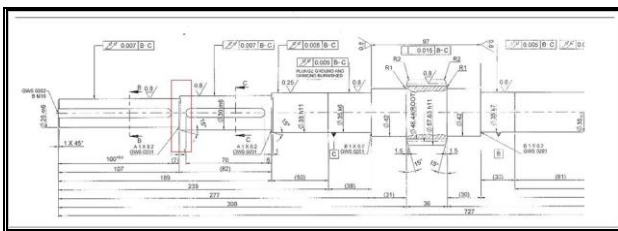
Failed area of shaft has been marked red in below drawing

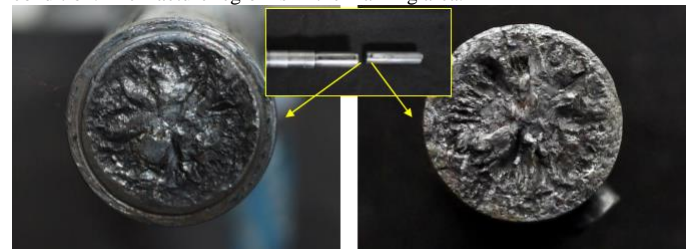
Plate: 2 Shows fracture surface view. Despite some rubbing marks on fracture surface star shaped pattern is visible.

Plate: 3 Shows fracture surface view of the smaller part of shaft. Here also, star shaped pattern is visible with no deformation on the contours.

3. Visual examination shows relatively flat nature of fracture surface which is square to the shaft axis. However, fracture surface shows a starry pattern indicating torsional mode of failure. Fracture surface also shows post-fracture rubbing marks.

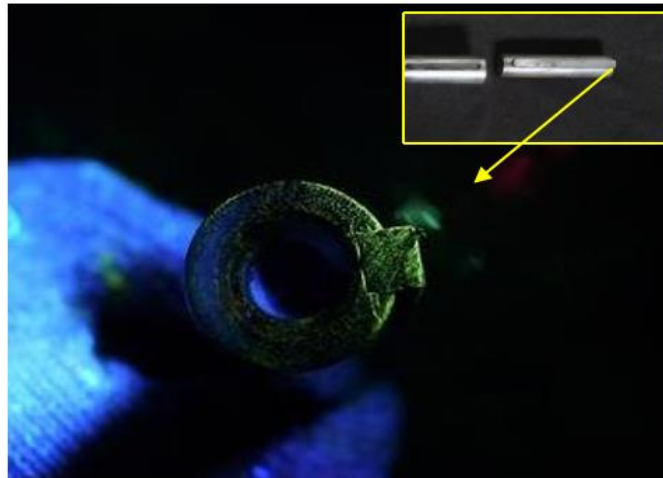
Plate: 4 The small surface plan view in WFMPI tested condition showing end opposite to the fracture surface. A linear indication seen at key way area

4. Dimensional measurement does not indicate any abnormal variation or distortion on the shaft. No deformation is seen on the key way contours.
5. WFMPi highlights randomly oriented hairline cracks on shaft surface at location even away from the fracture.

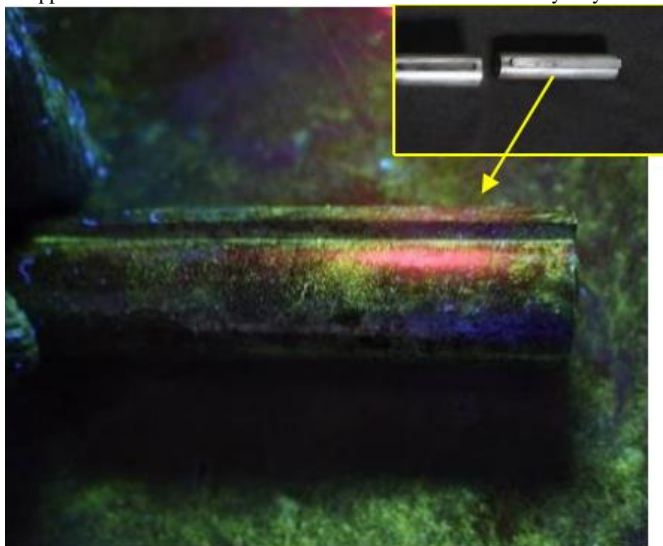
Plate: 5 Small shaft outer surface view surrounding the key way location. A tiny hairline crack like indication is seen on the surface.

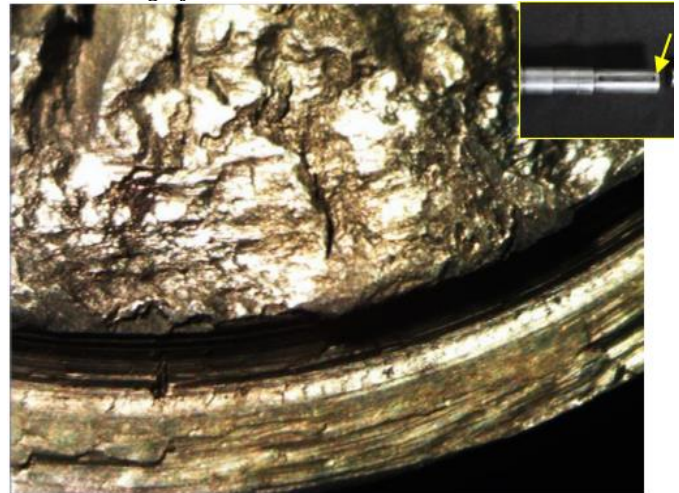
Plate: 7 Shows fracture surface low magnification view at the edges. The multiple ratchet marks are seen. Auxiliary cracking is also noticed. The rubbing is observed that seems to be post failure (10X)

6. Low magnification view highlights multiple ratchet marks on the fracture contours along with secondary cracks. This is followed by star shaped patterns accentuating torsion fatigue mode of failure.

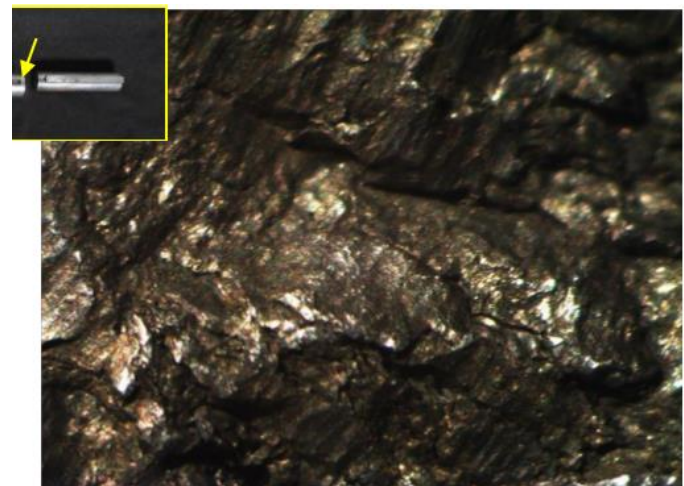
Plate: 8 Shows fracture surface low magnification view in the central portion. Petals of star pattern indicating torsional fatigue mode of failure are seen (20X)

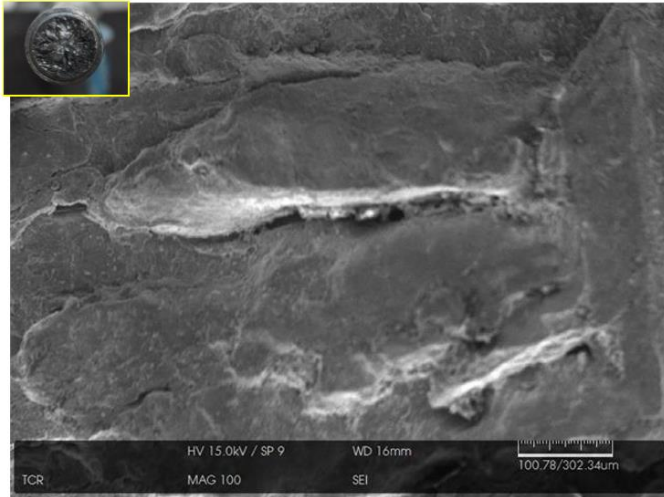
Plate: 9 Shows fracture surface view where petal like grooves indicative of starry fracture characteristic of torsional fatigue are seen. (100X)

7. MOC of the shaft conforms to EN 10084 grade 20MnCr5.
8. SEM highlights petals formed on the edges of the fracture surface indicative of starry fracture characteristic of torsional fatigue mode of failure.

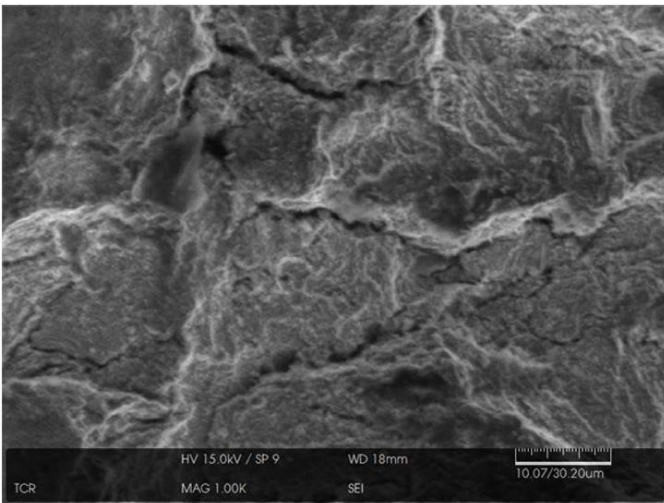
Plate: 10 Shows core portion of fracture surface view with secondary cracks. (1000X)

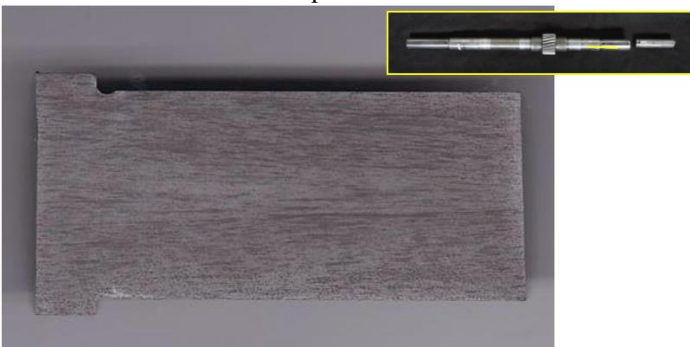
Plate: 11 Shows sample in macro etched condition. Normal grain flow is visible and it is free from any internal defects.

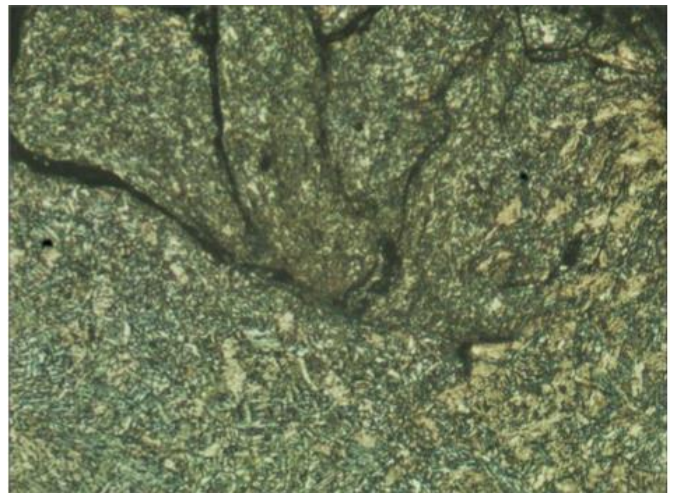
Plate: 12 Shows fracture edge microstructure of tempered martensite. Grains are slightly deformed at the edges. Crack network with uneven contours caused due to deformation is seen (200X)

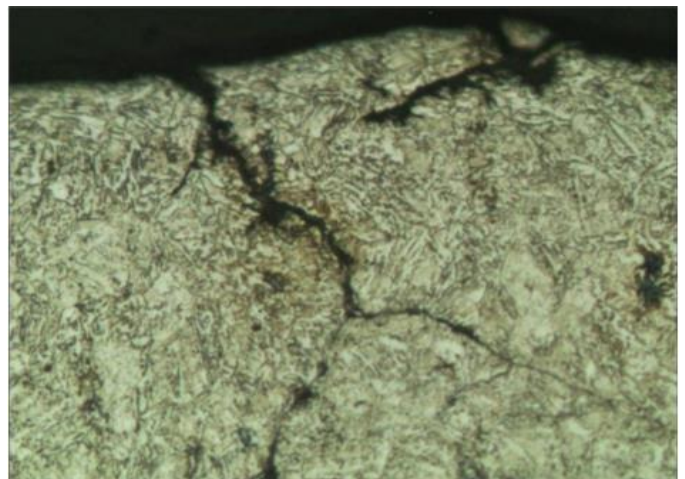
Plate: 13 Shows fracture edge microstructure of tempered martensite with ferrite traces. Transgranular cracking with fine tips and non-uniform contours are seen. (400X)

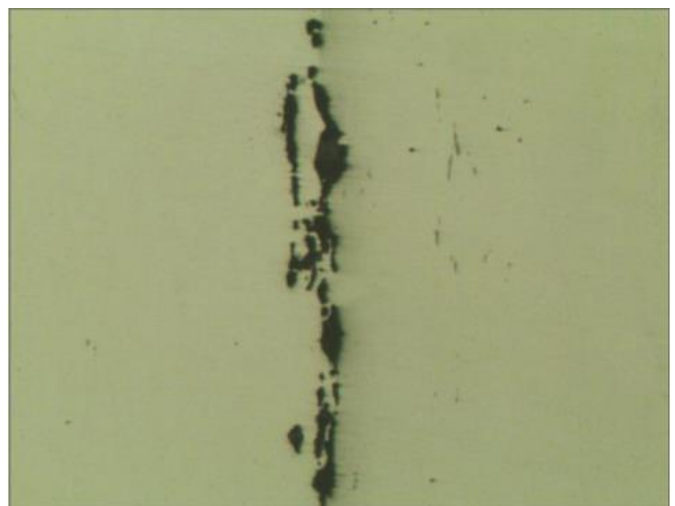
Plate: 14 As-polished view showing internal discontinuity which appears to be scale entrapment. (100X)

1. Reasons for jamming of the shaft during service required to be deliberated from the operation conditions.
2. The shaft quality needs to be improved from metallurgy point of view in terms of reduced inclusions and freedom from center line discontinuity. Design expert may be consulted for acceptance standard.

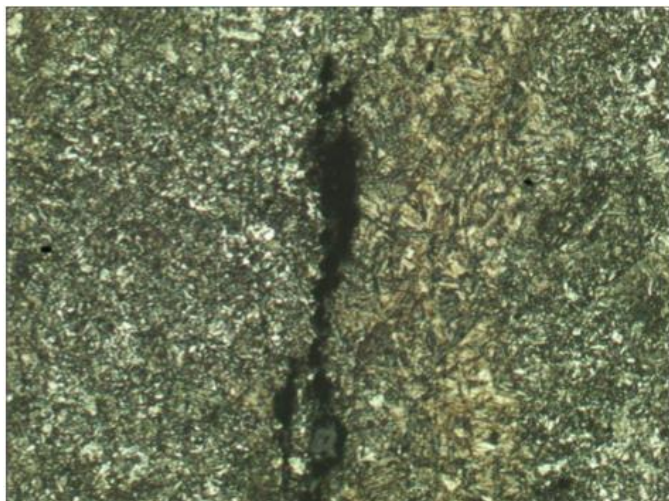
Plate: 15 Shows scale entrapment assuming the shape of crack with non uniform contours. Microstructure is tempered martensite with traces of ferrite. (200X)

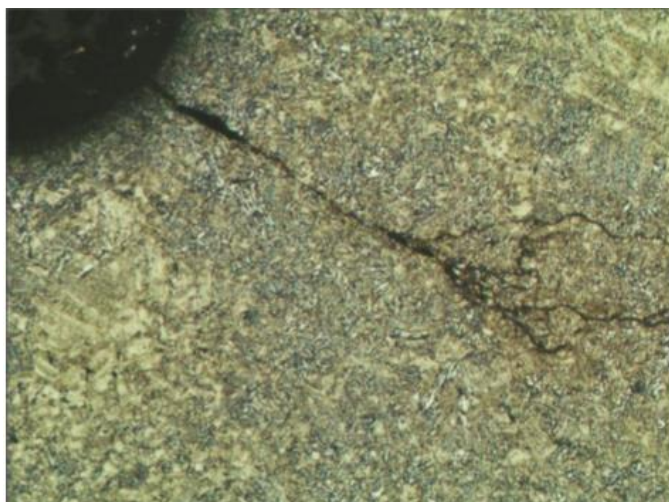
Plate: 16 Shows crack initiating from the keyway contour that has become branching in nature as it propagates. Microstructure is ferrite in traces and tempered martensite. (100X)

- Fracture surface indicates cluster inclusions and cracks having random contours. The grains at fracture edge are deformed with cracks.
  - Transgranular fatigue mode of cracking is seen initiating from the key way contours. That is away from the failure region.

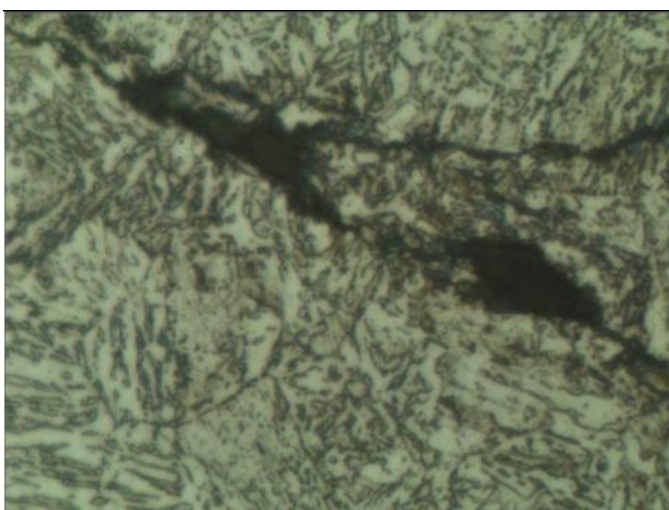
Plate: 17 Shows high magnification view at crack tip with branching tendency. Microstructure is ferrite traces and tempered martensite. (1000X)
