The Causes of Dam Failures a Study of Earthen Embankment Dams on the Copperbelt Province of Zambia

Abstract— The prime purpose of this paper is to summarise the study that aimed at establishing the risks and causes of dam failures associated with earthen embankments dams on the Copperbelt province of the Republic of Zambia.

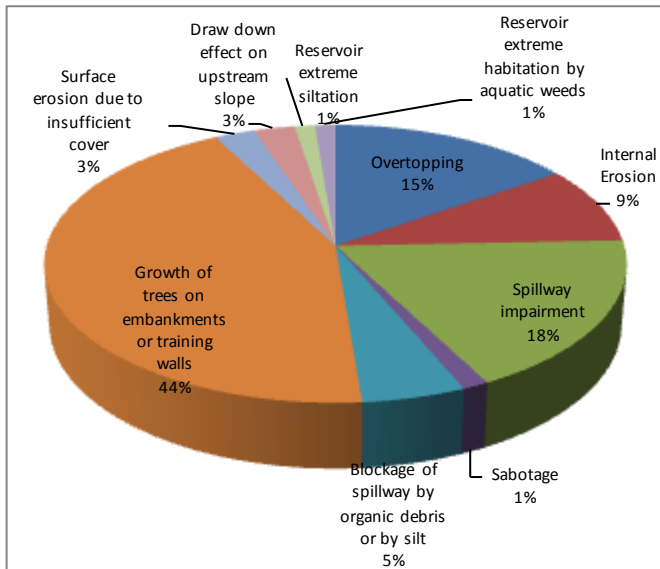
Fig 5.1: Observed anomalies responsible for risks of dam failures

The results in table 5.2 and its supplementary figure 5.1 shows that, the anomaly of letting trees grow on the embankment and training walls dominated with 42%. In other words, out of 43 dams, 37 exhibited this anomaly. In fact it was noted that in some instances not only did the trees grow naturally on the embankments and spillway area, but they were actually planted with the notion of reinforcing the areas in question.

As a result, by focusing on lethal anomalies it was noted that of the dams at risk; spillway impairments were the most pronounced with 21% each and seconded by overtopping with 16%. Coming third was internal erosion with 9%. Still amongst the lethal anomalies was 5% for blockage of spillway by floating organic debris and the least was Sabotage at 1%.

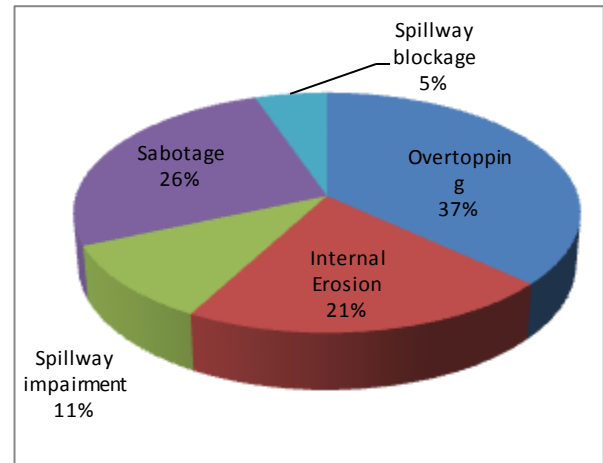
Fig5.2. Observed anomalies responsible of causing dam failures

On the other hand figure 5.2 shows the anomalies that were responsible of the failures. Overtopping was the most pronounced with 37%. This was surprisingly followed by failure due to Sabotage accounting for 26% and then internal erosion with 21%. Others recorded the lethal anomalies that had caused failures were spillway impairment with 11% and the least was Blockage by organic debris or silt with 5%.

A significant point that was drawn from figure 5.2 is that its details aligns themselves to most of the existing literature as those from [6][2][7]and [8], where it has been stated that, “Dam breaching due to overtopping has significantly claimed more embankment dams than any other cause of dam failures.

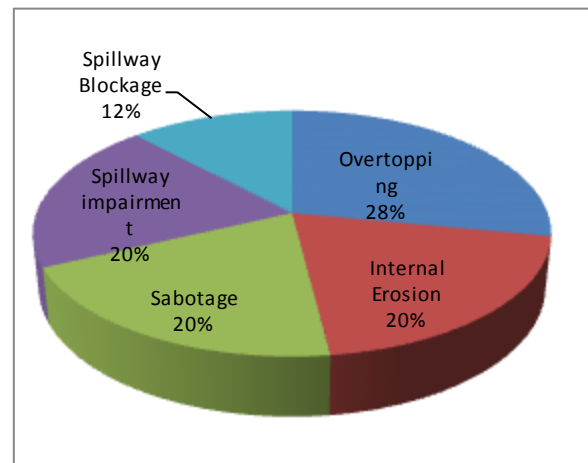
Fig5.3. Observed anomalies responsible of causing dam failures and failure attempts

Analysis of anomalies for the referred to group of 21 dams is displayed in figure 5.3. Which reaffirms that overtopping with (30%) still dominated then followed by equal proportions of spillway impairment with (19%) and then internal erosion with (18%), sabotage with (18%) and spillway blockage with (11%) whilst the list was growth of trees on embankment and training walls with (4%). This outcome also gave a further affirmation of a report by [8], where it has been stated that overtopping has significantly claimed more dams than any single cause of dam failure and accounts for 1/3 of recorded dam failures.

It is worth to note that the two (2) recorded counts of anomalies for spillway impairments consisted of failures that occurred along the interface (contact) area of the spillways and earthen embankments, implying that internal erosion was also at play. This combination is as reflected in failure incidents of St Marys and ED dams in table 5.2.

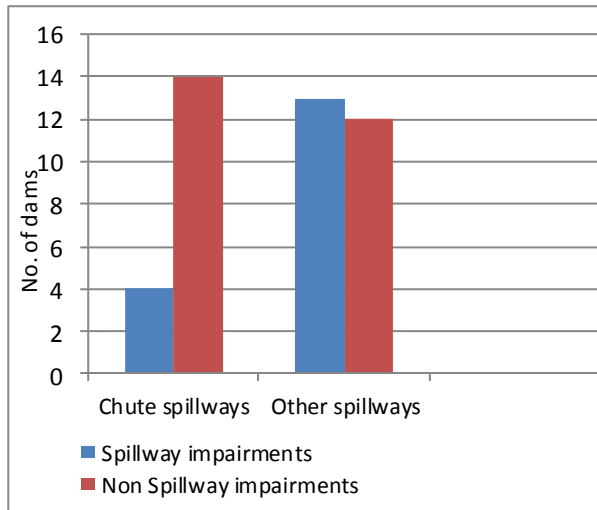
Fig 5.5 Failure resistances of chute spillways vs other spillways

Evaluation of data in figure 5.5 shows that 4 out of 14 dams with chute spillways had encountered spillway impairments whereas 13 out of 32 dams with other spillway types encountered spillway impairments. In other words only 29% of chutes spillways had impairments and 41% of other group of spillway types had impairments, indicating that chutes spillways were less vulnerable to failure.

Furthermore, this data was subjected a Chi square statistical by taking chute spillways as a control sample. However, the value (χ^2) calculated from the Chi square test was 3.906 indicating that chutes spillways were found to be significantly less vulnerable to failures than the other types of spillways grouped together at the level of significance of 0.05.

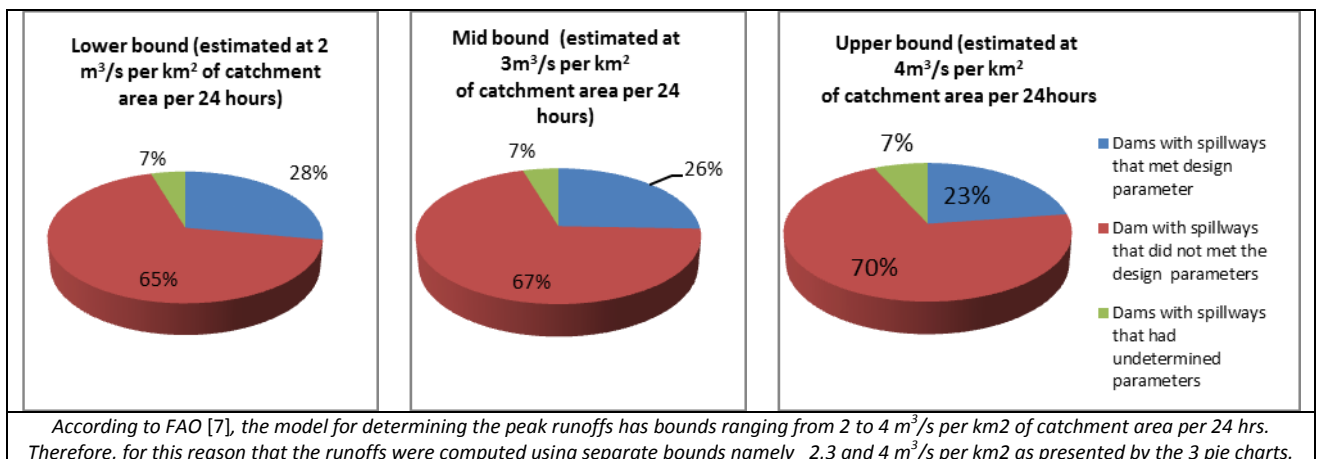
Fig 5.8: A comparisons of existing spillway design capacities with peak runoffs

Information in figure 5.8 depicts that, the majority of the dam had spillways that could not meet the basic hydrological requirement for the kind of catchment area they had been built in. Results show that under the lower bound, 65% of the dams could not meet required specifications whilst 67% and 70% were figures for mid and upper bounds respectively. Nevertheless, note that 7% of the dams in each bound had parameters that were not fully determined due to complexities
