Urea Stripper Tube Leakage

Prem Baboo

National Fertilizers Ltd. India

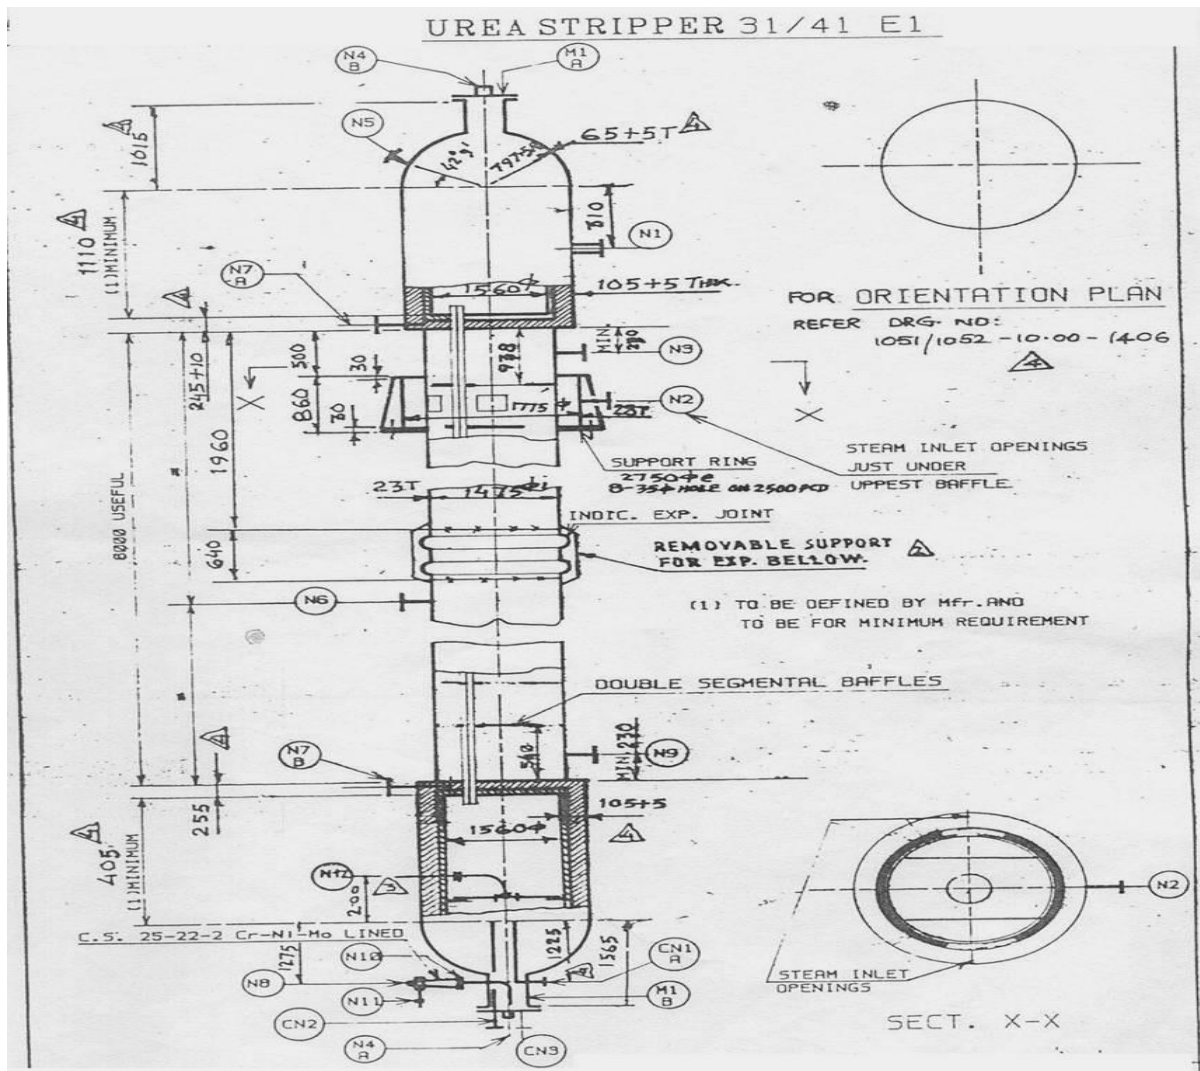
Fig-2

The tube sheet thickness is 255 mm including 10 mm overlay as shown in the figure-2. The leakage develops when overlay eaten with corrosion/erosion, less passivation. The condensate outlet of stripper collects to steam condensate drum. The rest energy of this steam condensate

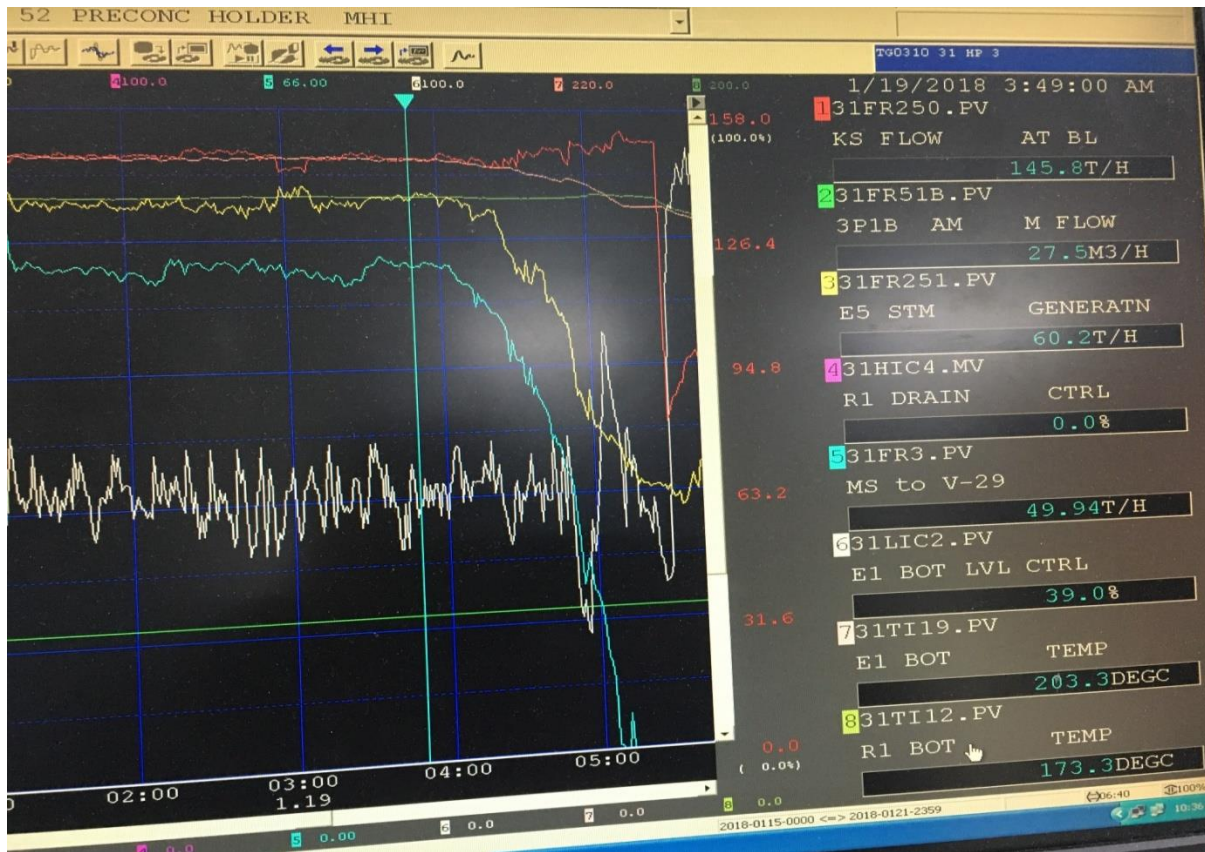
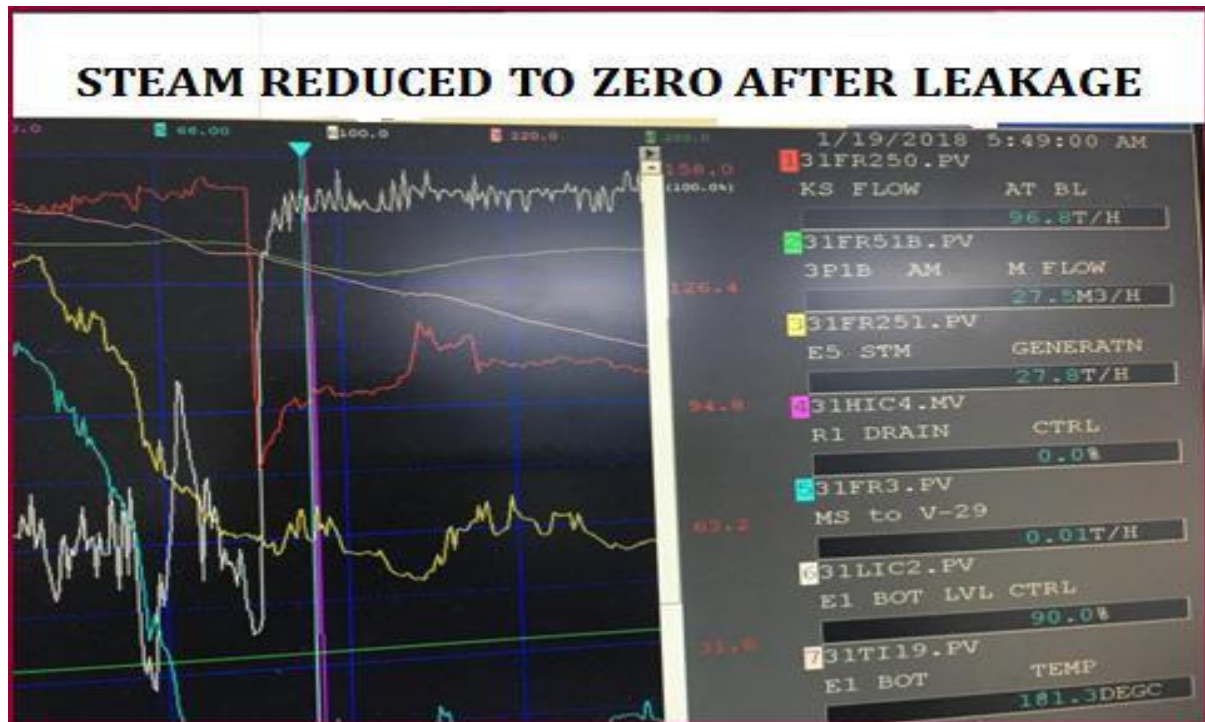
Fig-4

The main reason of plug failure is old age of equipment i.e. 21 years old vessel. The old 55 numbers tube plugs failure one by one due to layers of welding gradually deteriorated. Corrosion and exposure of hidden defect in tube-to-tube sheet joint. Lack of passivation air. Leakage was so heavy that steam to stripper turned to zero immediately and stripper shell immediately pressurized up to PSV set value i.e. 26 bar, as shown in the figure-4

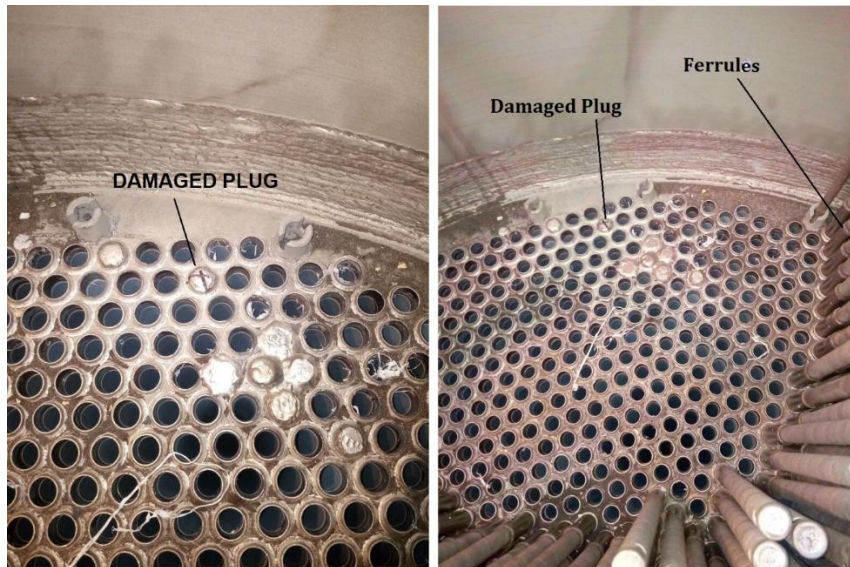
Fig-5

After the confirmation of leakage in both the channel it's the responsibility of Inspection and welding by expert welder to arrest the leakage in Urea Stripper. Major culprit plug leakage detects easily without applying soap solution air was coming from the damaged plug. For further minor leakage detection, a team was deputed for top & bottom channel. Following minor leakages were also detected as shown in the figure-8.

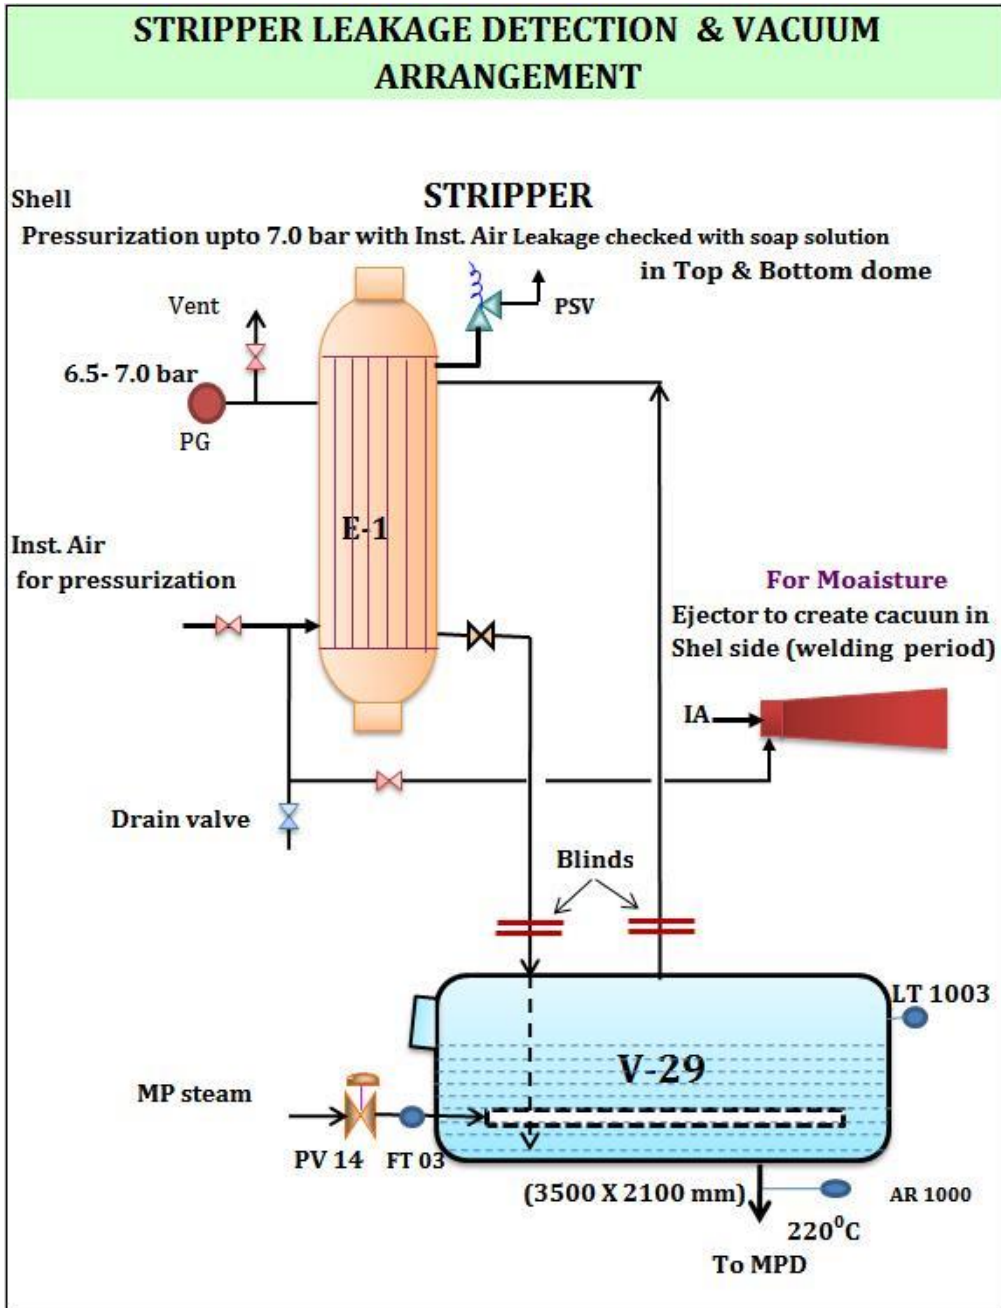
Fig-7

Arrangement as shown in the figure- 7 was done for getting tube leakage detection. Blind are provided to following equipment lines.

1. Steam to shell side inlet line
2. Outlet line i.e. V-29 vessel

The Shell side pressurized with instrument air at the pressure 7.0 bar and leakage detects with soap solution in top & bottom dome(Channel). Air & soap solution test is the most effective and safe for detection of leakage. Although it is the time consuming test and finding the defects but increasing the inspectors during the test serves the purpose. The test was carried out by pressurizing the shell side with

1. Replaced three old plugs at top channel.
2. Two number in bottom channel.
3. Two number new tubes plug at top & bottom.
