## Verification of Balance of System for Solar Photovoltaic Power Plant

*This paper presents results of the initial field inspection report of 10kWp Grid Connected Power Plant using Multi-crystalline PV Modules at IIT Gandhinagar-Ahmedabad. The inspection was carried out according to standard IEC 62446, Grid Connected Photovoltaic Systems - Minimum requirements for system documentation, commissioning tests and inspection, Edition 1, May 2009. Qualitative studies are made on physically visible defects such as gridline fading, corrosion of module frame, absence of grounding, hanging of wire cords, terminal box labeling etc. Initial verification takes place upon completion of a new installation or completion of additions/ alterations to existing installations. Periodic verification is to determine whether the installation and all its constituent equipment remain in a satisfactory condition for use. Here, the initial inspection is carried out and the effect of initial field exposure on the modules indicates that the qualification standard (s) needs to be reviewed and revised if the modules are to perform for long term under operating conditions.*

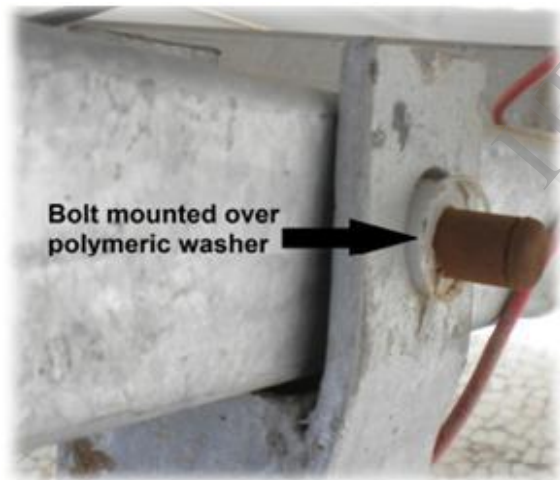
Between the AC and DC sides and that earth connections have been constructed so as to avoid corrosion (IEC 60364-7-712.312.2:2002). However, it was found that the mounting structure provided was considered as the means of grounding. The connection bolts of the structures were found to be corroded. Moreover the bolt was mounted over polymeric washer (Refer Figure 1) which rules out the continuity of grounding means.

**Figure 1: Bolt position at the frame**

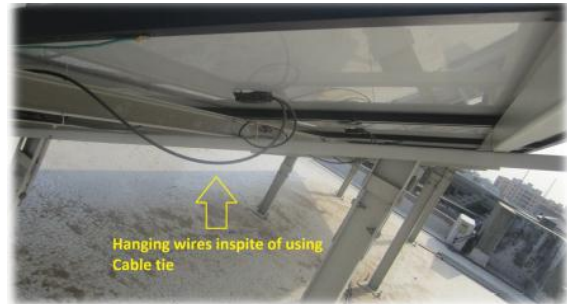
This clause also speaks of wiring systems been selected and erected to withstand the expected external influences such as wind, ice formation, temperature and solar radiation (IEC 60364-7-712.522.8.3:2002). The conditions in the field didn't comply with the clause. The average wind speed on the roof of site measured for the day was more than 40 m/s. In spite of using the cable tie, the wires are found to be hanging (Refer Figure 2) which may result in losing the property in due course of time.

**Figure 2 Wires hanging down the module**

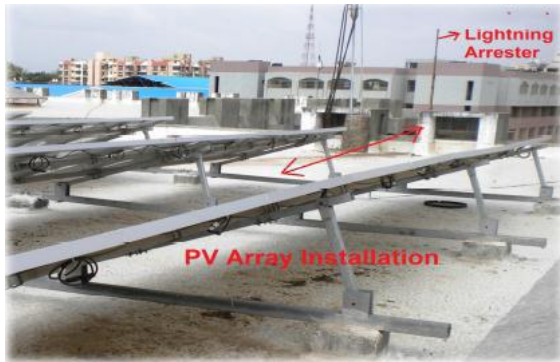
Lightning arrestor was installed as Lightning Protection System; however, it was not installed at the right place (Refer Figure 3).

**Figure 3 Position of lightning arrester**

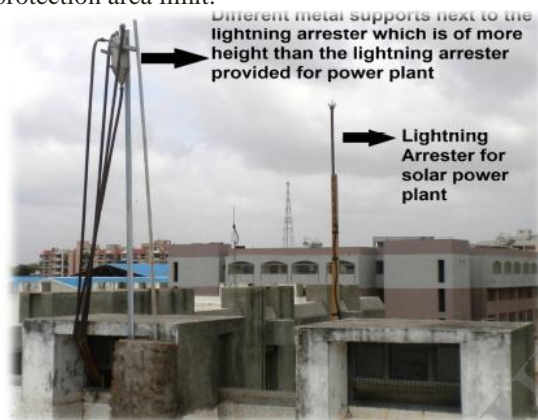
One more metal structure was present next to the existing lightning arrester (Refer figure 4). Also the lightning arrester fixed is slightly away from the PV Array installation (4 to 5m form the PV Array) which will not cover the entire PV Array within its protection area limit.

**Figure 4 Length of lightning arrester falling**

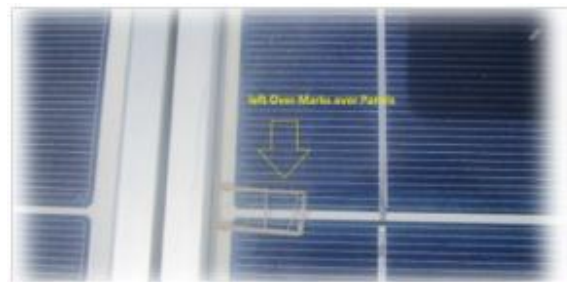
A mark of adhesive was observed on almost all the panels. These marks were because of the tape used during the Packing (Refer Figure 5). These leftover marks may result in further degradation of system performance due to the shade phenomenon

and lead to hot spot issues.

**Figure 5 Leftover Marks**
