Advantages of using EMV in Auditing Construction Processes

We analyzed the reconstruction and restoration works of the "Former Kinostudio Building", Cultural Monument of the Second Category, shown in Figure 3.1 [8]. The works which will be subject to restoration, since it is a monument of culture and based on the law of cultural heritage, represents a high risk in terms of performance of reference prices, quality and quantity specified in the project. The object is located in Tirana and the process of restoration was carried out in 270 days, the original deadline for its completion has been 180 days. As evidenced, the reconstruction and restoration process was completed 90 days later. The value execution of the reconstruction and restoration project is 103,258,474 ALL. Engineering intervention and restoration work was carried out during the years 2013 -2014.

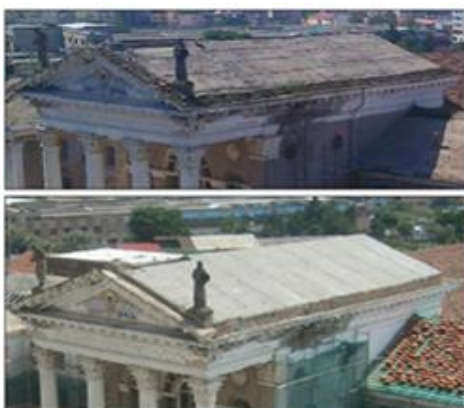
Figure 3.2 Roof leveling layer

- Reinforced concrete leveling layer (applied on the roof). The Allowance Fund Statement presents 175 m^3 and the Measurement Sheet presents in an analytical way a total volume of 175 m^3 . From the verification on the ground and the technical design of the project in electronic version, the photos and the Measurement Sheet, it results that are constructed a volume of 125 m^3 of Reinforced concrete leveling layers. During the construction of the concrete roof, it is not used reinforced concrete leveling layer $t = 10 \text{ cm}$ (applied on the roof), as a consequence, there is a difference of 50 m^3 . The difference in volume is $175 \text{ m}^3 - 125 \text{ m}^3 = 50 \text{ m}^3$. From the calculation of PROING® computer software, Cost Performance Index for this work is $CPI = 0.71 < 1$. This value indicates that the amount paid is higher than the real value of the works, where the volume of work performed is smaller than the one presented in the Measurement Sheet.
