An Experimental Study on the Flexural Retrofitting of the Partial Damaged Reinforced Concrete Beams by using High Performance Fiber Reinforced Cement-Based Composite (HPFRCC)

Abstract— If an individual structure, damages under severe conditions (e.g. earthquake, nearby excavation, etc.), it can't be any more reliable to tolerate designed loads and needs for retrofitting and restoration in structural parts. because of high seismicity, existence of old structures, defects caused by environmental and internal conditions of materials, and also problems in the design phase and implementation of structures, retrofitting and restoration of structures is in a high level of interest. Due to increasing development of building construction, using the novel ideas in design, build and finding the appropriate materials of the building is necessary. Therefore, due to high demand for developing new methods by using high performance materials, the main purpose of this paper is using HPFRCC fiber concrete to recover the damaged beams under loading conditions and also improvement of concrete beams with experimental approaches to increase the ductility and moment capacity and enhance the durability o

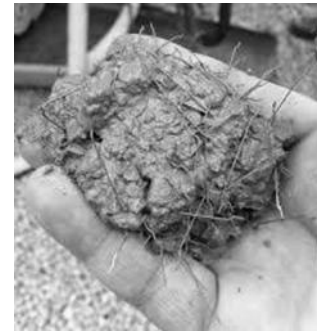
The type of fibers used in this research is showed in Fig. 2 and the properties of this steel fibers is showed in table.III.

Fig. 2. Steel Fibers

Since steel fibers have unique specification in comparison to other fibers, they have been used for retrofitting the concrete. Accordingly, these steel fibers mix with the concrete with 2 percent of volume ratio (see Fig.2). Two damaged beams have been retrofitted by forming a layer of HPFRCC by shuttering and concreting in molds at bottom parts of the beam in U-shape. It is worth noting that the Thickness of HPFRCC layer in all samples is equal to 2 Cm (the minimum practical thickness)

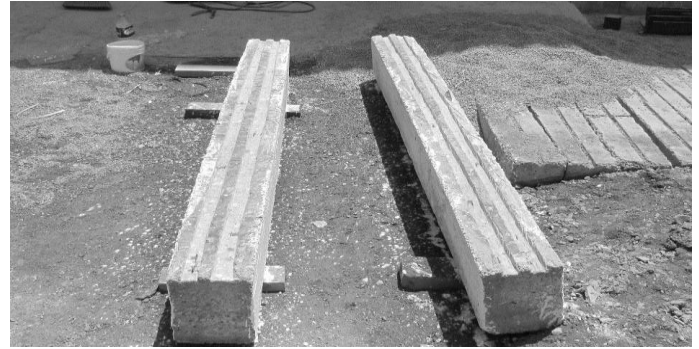
First beam as the reference beam has been subjected to severe load to measure the final crack and two other beams which considered as damaged beams subjected to 35 percent of final load (P_{max}) of the reference beam. In order to be sure of unity and combination treatment of HPFRCC layer and existing concrete in beam (as you can see in Fig.5) some grooves with 3 Cm depth and 4 Cm width has been created by using the electrical Grinder machine.

Fig. 5. Creation grooves in tensile surface

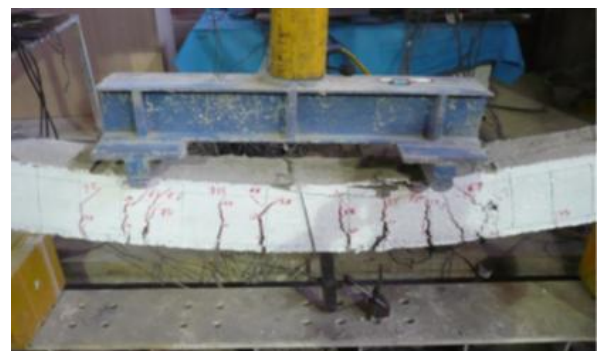
The RC beam with rectangular cross-section has been considered as reference beam which its reinforcement is quite similar to other samples. This hinged support beam has been subjected to the 2-point loading pattern. Before starting the test, the equipment installed on sample and by placing the jack on sample, static loading began and loading on beam started which you can see the loading of RC beam in Fig.7 and its Load-Deflection curve in Fig.8.

Fig. 7. Test of RC beam

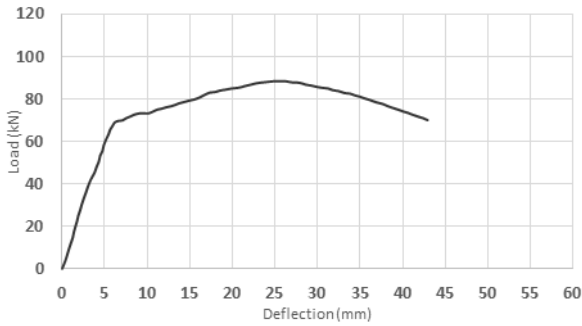
Fig. 8. Load-deflection curve of the RC beam

Beam	P_{cr} (kN)	Δcr (mm)	P_y (kN)	Δy (mm)	P_u (kN)	Δu (mm)
RC	40	1.58	65.8	5.8	89	39.5
B35H1	52.5	2.1	114.5	6.8	136.28	43
B35H2	51.2	2	118.2	7.6	135	47

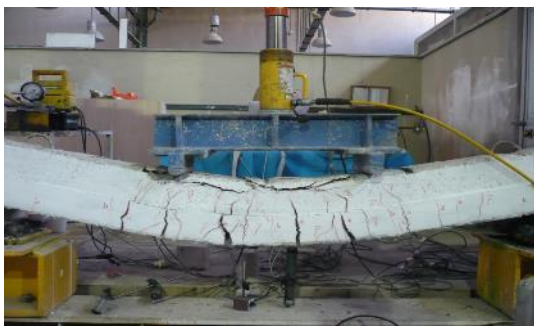
After loading the reference sample and reaching the maximum loading of reference sample, we start the loading of the two other beams to 35 percent of final load in order to have the damaged beams then we start retrofitting them. Finally, we start loading the retrofitted beams, see Fig.9 . Curve results are available in Fig.10 and Fig.11

Fig. 9. Test of beams B35H1 and B35H2
