Analysis, Design and Application of Retrofitting Techniques in Various Structures

Abstract— This research paper is focused on the structures which lack the required strength as per the guidelines of earthquake building code to sustain the seismic force. Suitable retrofitting techniques are suggested after proper analysis and documentation at different sites. The basic idea behind the strength enhancement of structure is based on the concept of improving the flexibility, stiffness, ductility and unity of the structure. The method of retrofitting improves the seismic force sustaining capacity of various components of building without stress concentration at critical points.

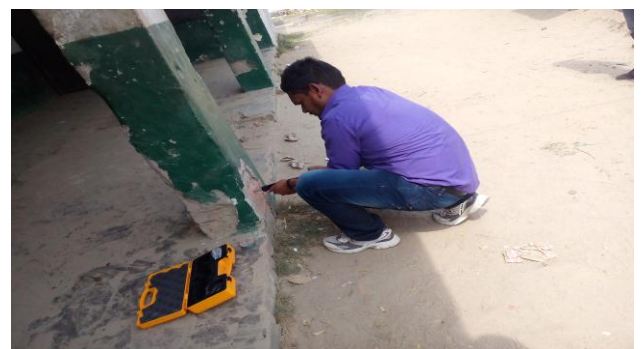
To determine the existing strength of structure we performed the rebound hammer test. It is a Non destructive test performed on concrete surface to determine the compressive strength of the portion. Compressive strength is obtained by comparing the rebound number with the conversion chart provided by the manufacturer of rebound hammer.

Figure 1 :- Rebound Hammer Testing

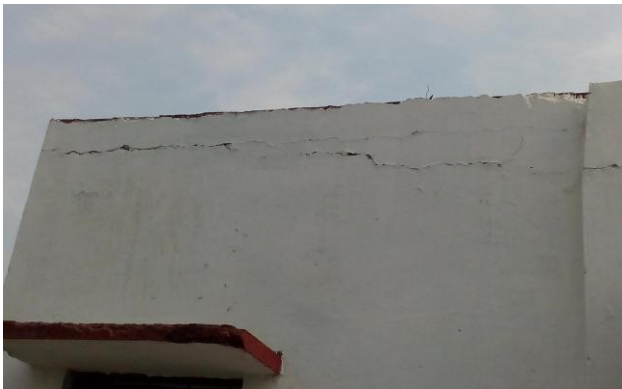
Figure 2:- Roof Wall Crack Visible

1. *Cracks stitching* :- The cracked portion of the wall should be repaired by using bolts and metal wire to stitch it. To improve the quality of metal stitching V-groove can be cut on the surface.
2. *Use of steel plate* :- Steel plates or angle can be used to hold the wall corners and improve interlocking of brick work.
3. *Anchoring the walls*:- The anchorage of the roof is required to increase the lateral support of wall at the top. It also enhances the load transfer mechanism of the wall and slab. Therefore stress concentration can be minimized at the base.

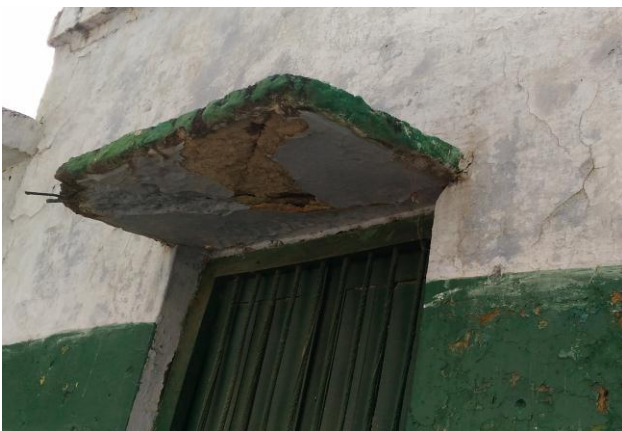
Figure 3:- Cracked Hanging Slab

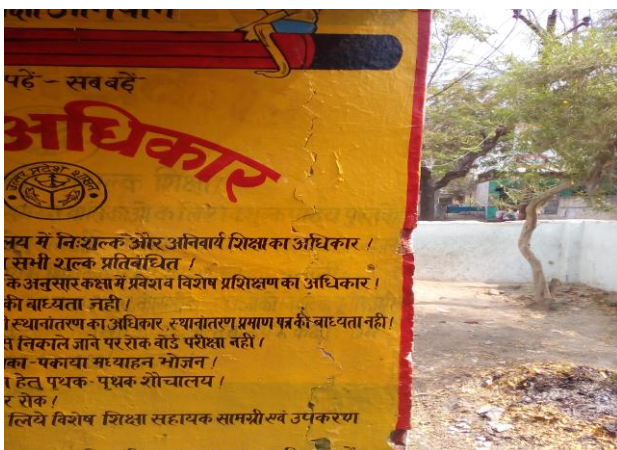
Figure 4:- Corner Wall Crack
