Black Spots Studies On National Highway 209 Kanakpura Road Bangalore For A Stretch Of 15km.

Shaik Salauddin.* , Reshma. E. K +

*P.G. Scholar, Highway Technology, DSCE, Bangalore

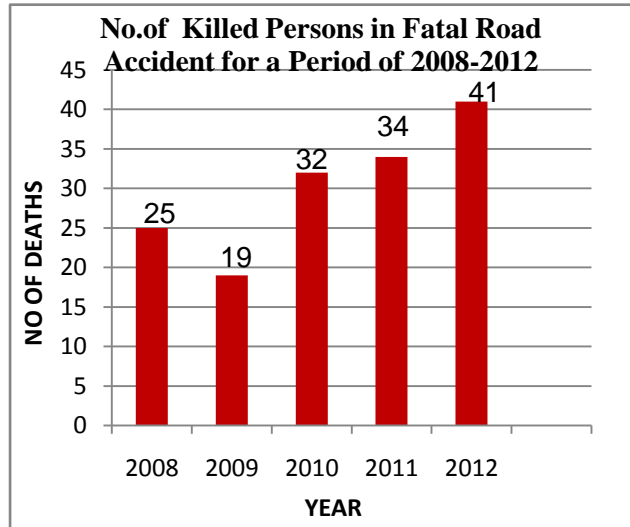
Chart-1: Statistics of killed persons for a period of 2008-2012 on NH 209 Kanakpura Road, Bangalore.

Accident data for NH-209 Kanakpura Road for a stretch of 15km is obtained from Talaghatpura Police Station (Table-1) and chart prepared for the same is shown in Chart-1.

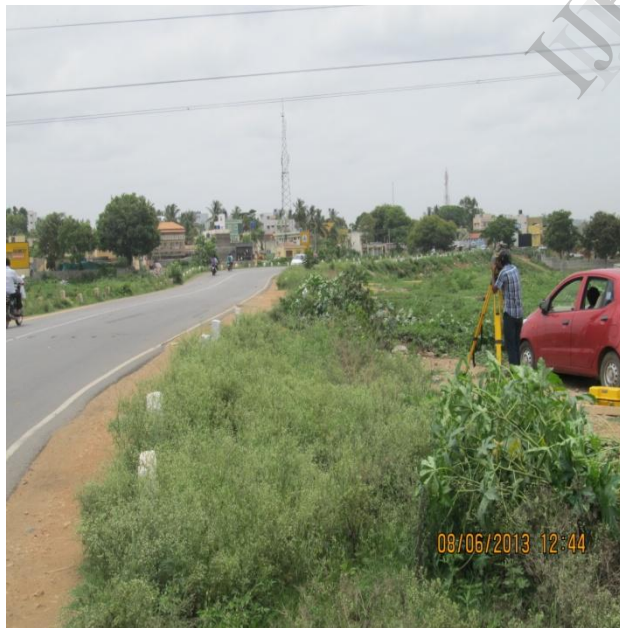
Plate 1 Absence of barricades along Nelguri kere, Kanakpura Road Stretch Bangalore.

- Two of the eight black spots are located on tank bunds with narrow shoulder width. Strong barricades have not been erected to protect the vehicles accidentally falling into lakes. As an eco-friendly measure trees can be raised on tank bunds as an alternative to expensive barricades and embankments.

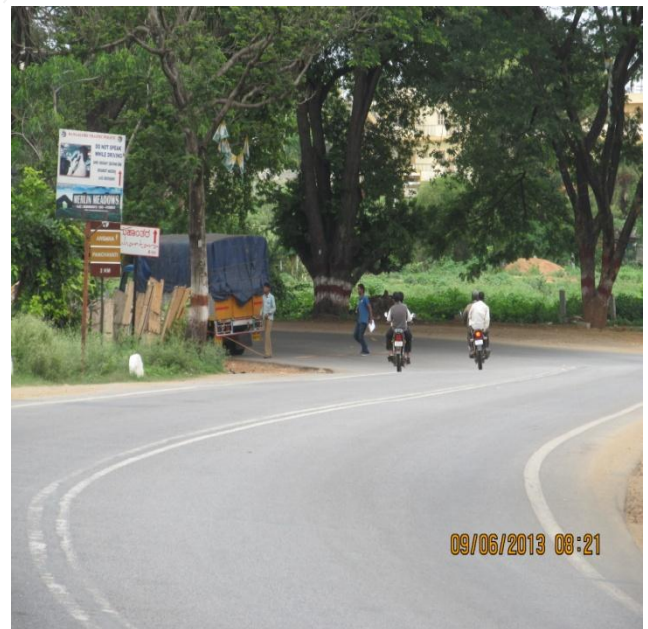
Plate 3 Blocking the view for driver negotiating s- curve due to Presence of huge trees along Kanakpura Road Stretch Bangalore.

- Visibility on inner sides of the curves is seriously restricted due to the presence of huge trees. The tree trunks are very close to the pavement edges. Any vehicle deviating from the pavement while negotiating curves or during overtaking of slow moving vehicles likely to cause an accident by hitting the tree trunk. Hence, trees which are very close to pavement edges have to be removed in the interest of public safety.

- Although, the geometric design for Kanakpura road stretch provides for restricted sight distances different categories of vehicles move in the speed range of 60 to 80 kmph. The inadequate sight distances contribute for traffic accidents. Hence, at few locations realignment of the highway is recommended to improve sight distances..

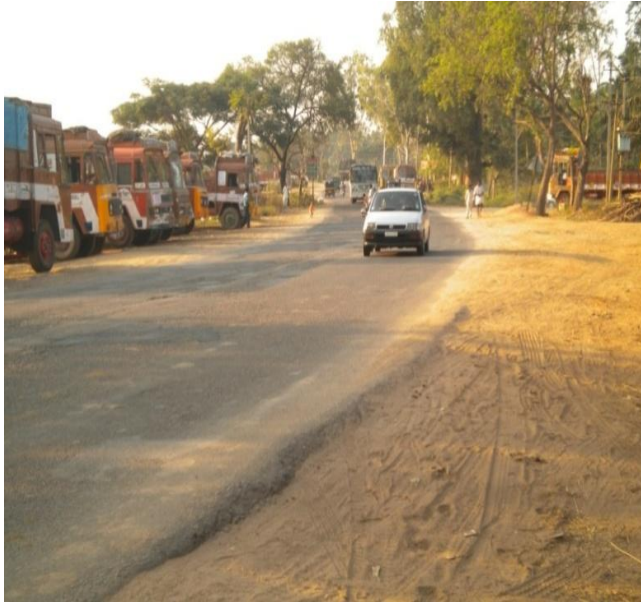
Plate 4 Illegal parking on the Highway shoulders at Kanakpura Road stretch Bangalore

- Illegal parking at the sides of the road is a major cause for accidents. Trucks parked on both sides of the road without parking lights and without sufficient clearance from the edge of the pavements obstruct free movement of traffic and also cause serious accidents. Educating the truck drivers and strict enforcement by traffic police will be helpful in curbing the practice of illegal and dangerous parking.
