Comparative Analysis on the Use of Septic Tank and Sanitary Sewerage Systems at Malali Housing Estate, Kaduna - Nigeria

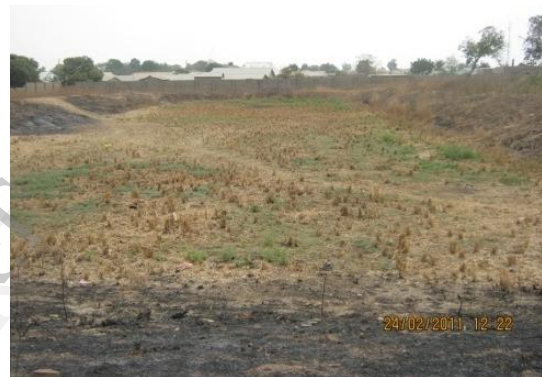
Figure 1: Visible shape of old WSP showing abandoned facultative pond

From the ESS condition survey conducted, no trace of sewer and manhole was found. The sewage Treatment Plant (STP) was bare. Only some visible shape of the facultative pond with grasses grown on the embankment and bottom were seen (Figure 1). Only one DN200mm AC pipe was seen at the STP (Figure 2). Sewage was seen lying stagnant at Kenya road due to lack of sewer that would convey the wastewater to a treatment plant.

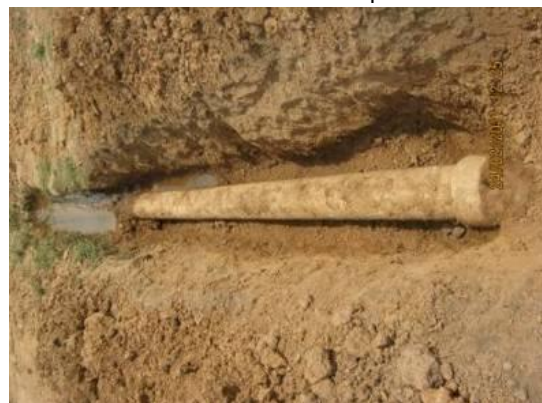
Figure 2: Broken DN200mm AC sewer close to the old waste stabilization pond

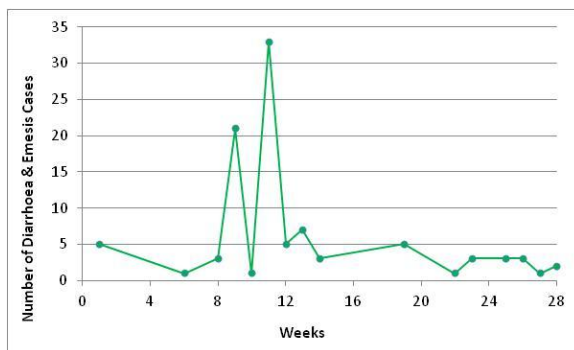
Figure 6: Disease Occurrence against weeks

Figure 6 shows that in weeks 9 and 11, there were outbreaks of diarrhoea and emesis. The highest case occurred in week 11 with a record of 33 cases while week 9 had 21 cases.

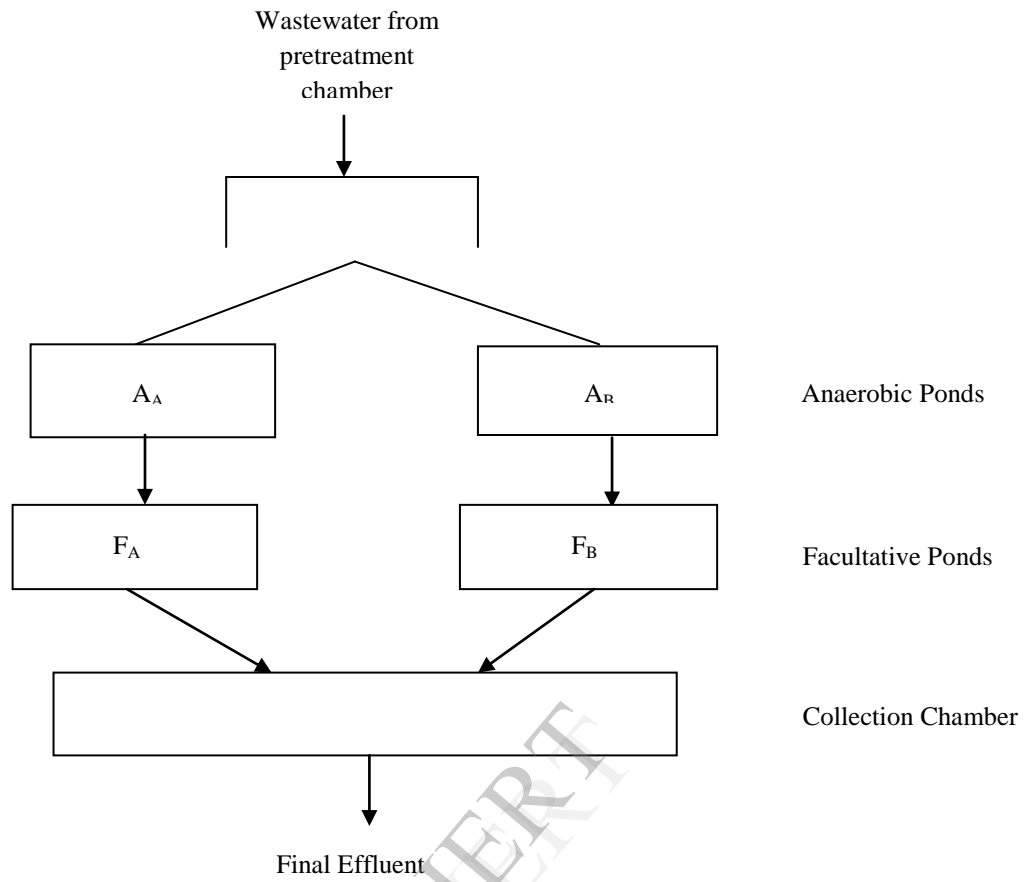
Figure 1: Process Flow Diagram for WSP

Based on the estimated population of the estate (5,650 in 2012, and 15,000 in 2037), a Waste Stabilization Pond (WSP) treatment plant consisting of anaerobic ponds and secondary facultative ponds in series was designed [16]. The dimensions of the designed waste stabilization pond are given in Table 1 below. One additional anaerobic pond and one secondary facultative pond are to be provided as spare. This is to allow for maintenance so that when
