## **Corrosion Behaviour of Bitumen Coated API 5L X65 Steel in Different Concentrations of HCL Environment.**

The research work investigates corrosion behaviour of coated X65 steel samples used for oil and gas transportation pipelines in different concentrations of hydrochloric acid medium at 30°C using gravimetric technique. The X65 steel samples were cut to corrosion coupons, and immersed into HCl solutions with pHs of 2, 3, 4, and 7 within a period of twenty one days. The results showed that bitumen coated X65 steel samples had better corrosion resistant compared to uncoated X65 steel samples in the studied medium. From the corrosion rate studied in HCl solutions (pH 2, 3, 4, and 7); uncoated X65 steel samples immersed in HCl solution with pH of 2 showed greater weight loss and recorded the highest corrosion occurrence. While coated samples in solution with pH 7 showed the least corrosion rate. Hence, bitumen coatings have a very successful record for protecting pipelines X65 steels against corrosion. Therefore, the results suggest that bitumen has the potential for future applications as a coating on X65 steels and pipeline steels in general

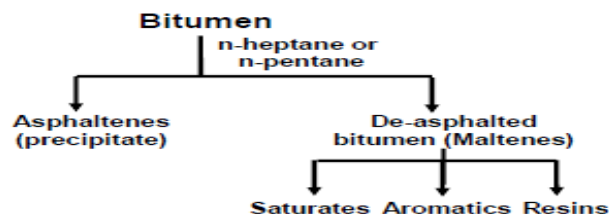
Figure 2: Separation of bitumen based on solubility (SARA fractionation)

Bitumen consists of complex mixture of hydrocarbons, the remainder being oxygen, sulphur, nitrogen and traces of various metals. The average bitumen molecular structures are gotten from molecular weight, elemental analysis and nuclear magnetic resonance data. It consists of one or two, 3, 4-ring condensed aromatic systems with several aliphatic side chains and alicyclic systems attached. Bitumen comprises about 25-35% aromatic, 15-30% alicyclic and 35-60% aliphatic carbon [20, 21].

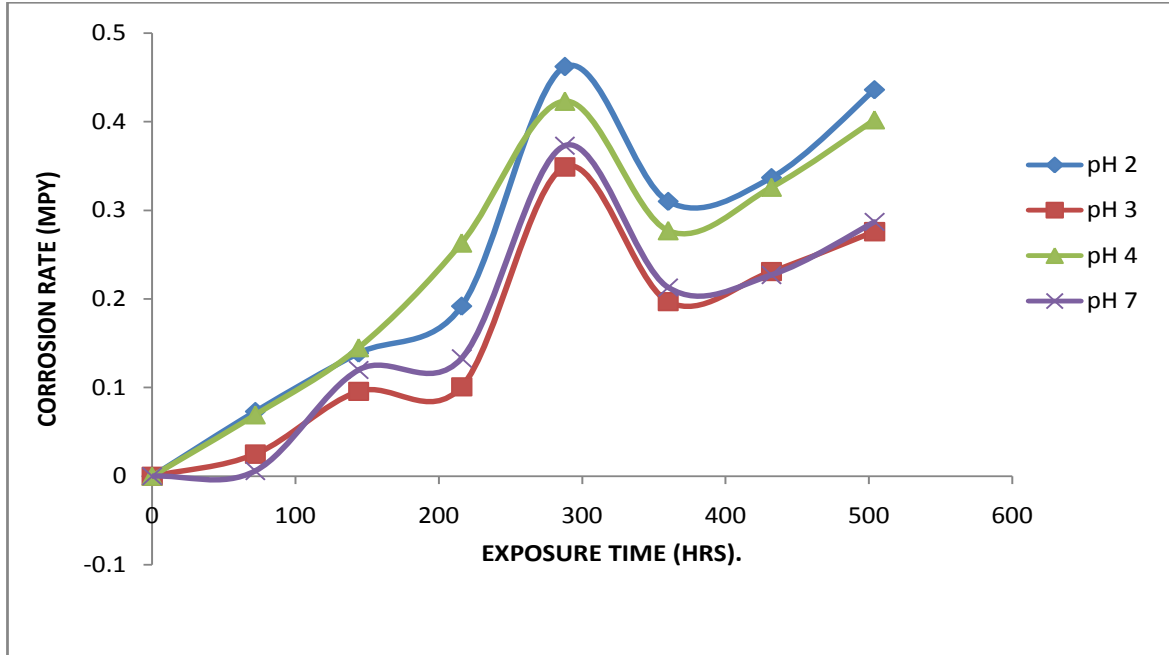
Figure 1: Variation of corrosion rate of uncoated samples with time in HCl with different pH.

Figure 1 provides the corrosion rate variations across all the uncoated samples examined in acid medium with different pHs. pH 2 recorded the highest corrosion occurrence. In this group, corrosion is initiated on the same day of exposure in all the samples tested. Samples studied in pH 4 are next to pH 2 samples in corrosion rating. pH 3 and pH 7 samples maintained closer characteristics till the end. The uncoated samples in pH 2 and pH 4 had very related features right from the first day of exposure till the end of the experiment. There is general increase in corrosion rate of the samples in different pH with slight sharp decrease followed by increase again. The increase in corrosion rate can be explained by the dissolution of the metal, where a passive oxide layer is being formed with time at the surface of the steel. This reduces weight loss till around 360<sup>th</sup> hour where the presence of chloride ions and moisture breakdown the porous passive oxide layer that is formed resulting in more corrosion of the steel samples.

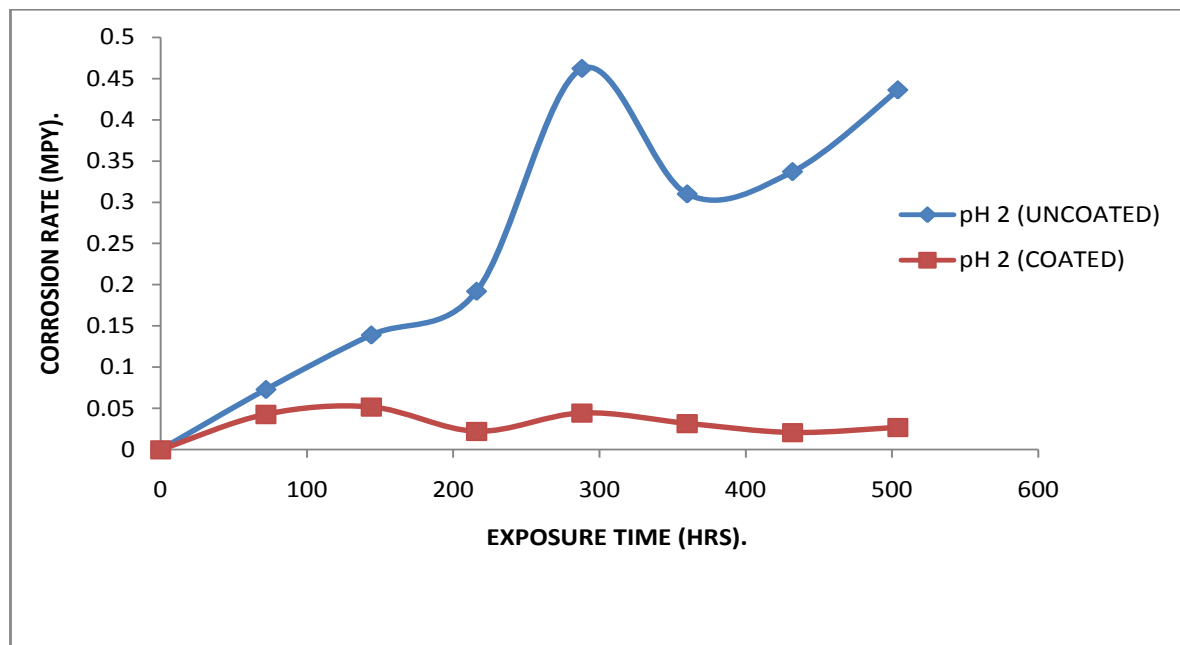
Figure 2: Variation of corrosion rate with time in HCl (pH 2).

Figure 2 shows the corrosion behaviour of uncoated and bitumen coated X65 steel in pH 2 of HCl solution. The bitumen coated steel showed a sharp increase and sudden decrease in corrosion rate. This could be as a result of destruction or break in the protective oxide film formed which exposes fresh surface of the metal to the environment. The dilution of the environment by the corrosion products could also account for the decline in the corrosion rate of X65 steel.

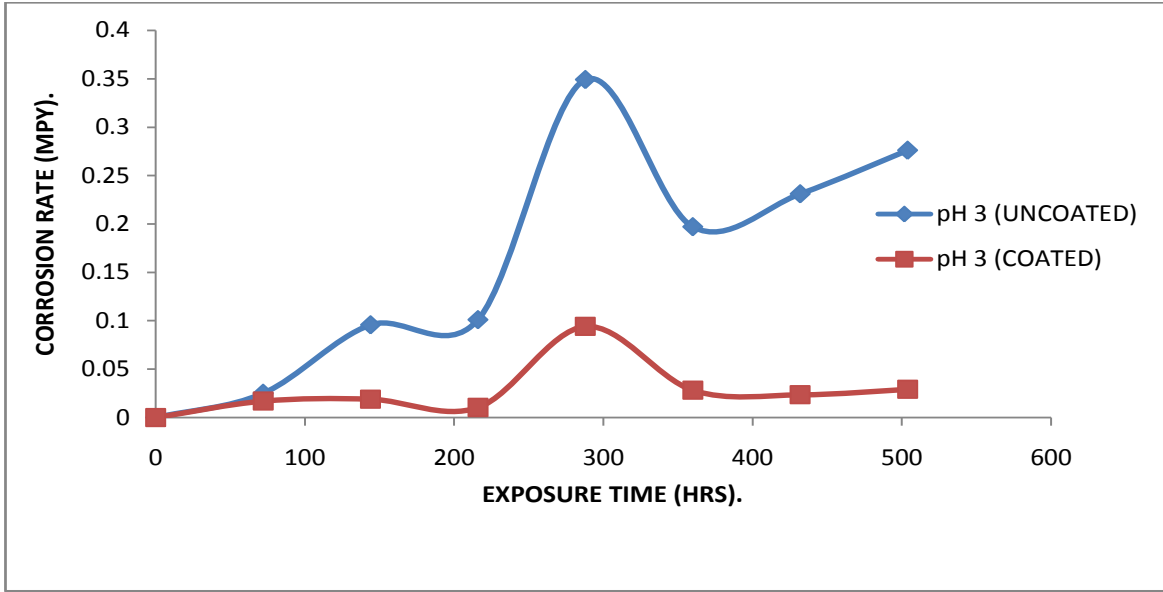
Figure 3: Variation of corrosion rate with time in HCl (pH 3).

The increase in weight of the coated sample is due to the water absorption of the bitumen coating through pores and micro-cracks as shown in Figure 3. This resulted in gradual coating de-bonding and the formation of blisters at the coating-substrate interface as corrosion could occur in the dis-bondment area leading to subsequent decrease in weight. The small reduction in the weight of the coated steel could be due to formation of iron (II) oxide and the attack of the chloride ion on the sharp edges of the steel samples which could not be properly coated due to the geometry. The comparison of the uncoated (control sample) and the spray coated sample shows though there is high water uptake of the coating.

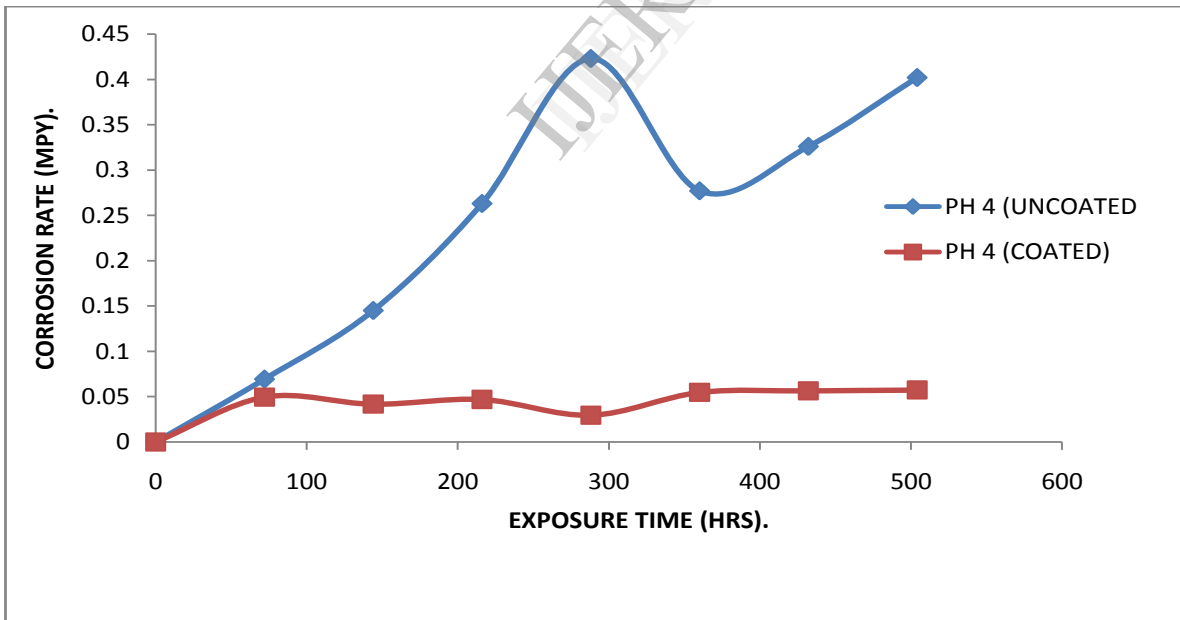
Figure 4: Variation of corrosion rate with time in HCl (pH 4).

Figure 4 shows weight change behaviour for bitumen coated steel samples in HCl medium of pH 4.0. There is increase and decrease in corrosion rate of the samples at pH 4. The decrease is due to a limited supply and reduction rate of oxygen which variably reduced the corrosion rate. The decrease in weight of the coated steel could also be as a result of the sharp edges of the coupons that did not adhere to the coatings. This allows the gradual dissolution of the metal, due to direct attack of the chloride ions on the oxide layer.

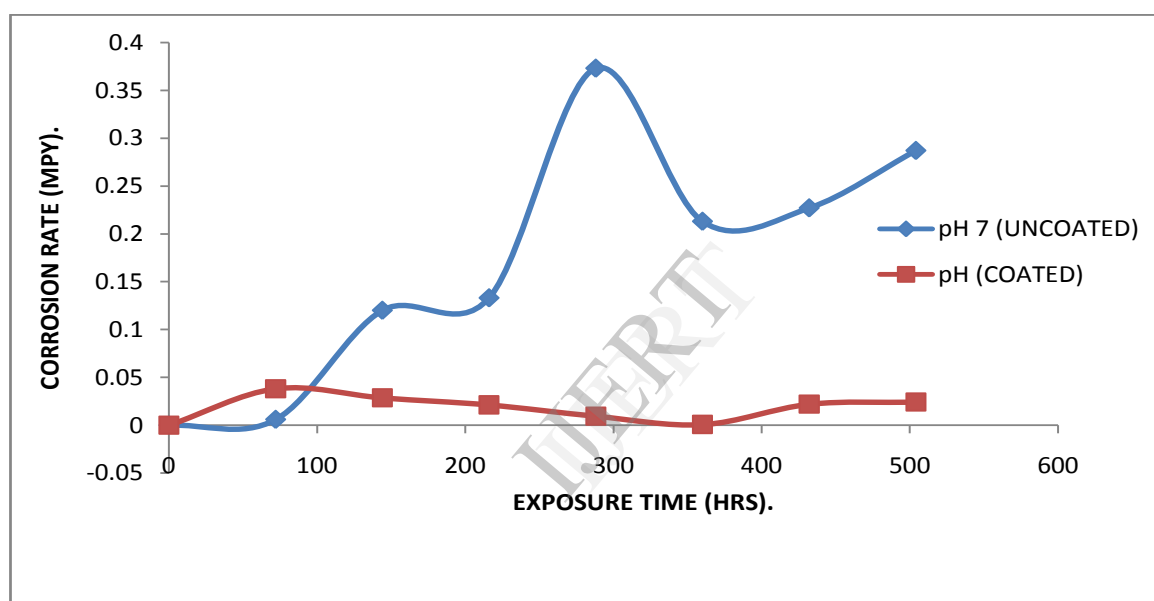
Figure 5: Variation of corrosion rate with time in HCl (pH 7).

In figure 5, the weight percent behaviour of the uncoated (control) and bitumen coated steel in distilled water solution of pH 7 is different from HCl solutions of pH 2, 3 and 4. This is due to different diffusion behaviour as a result of abrupt change in the concentration of the solution. Figure 5 shows decrease in weight in coated samples, after an initial increase in the weight of these coated samples. The comparison of the uncoated and coated samples shows that the coated samples corrode less than the uncoated samples.

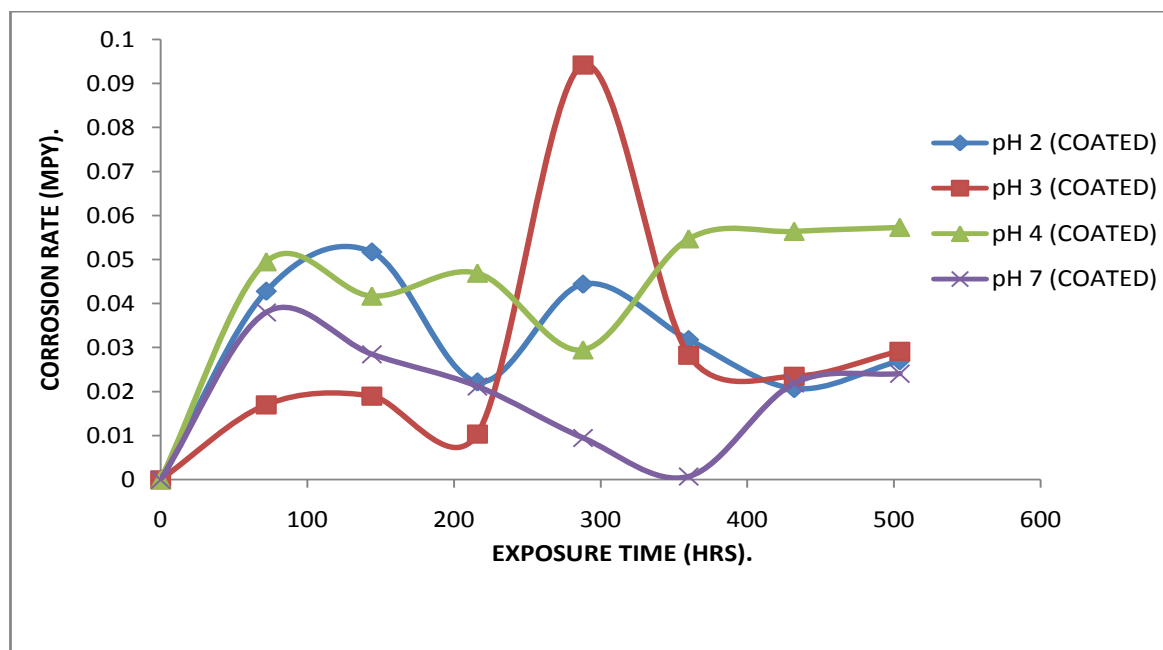
Figure 6: Variation of corrosion rate of coated samples with time in HCl with different PH.

In Figure 6, corrosion initiated the same day of exposure in all the samples tested. Corrosion rate variation across all the coated samples studied in corrosive environment could be found to be more in coated sample exposed to acid medium with pH 3 which also degraded earlier than the other coated samples studied in the acid medium. Coated sample studied in pH 2 has a sinusoidal increase and decrease. Samples in pH 7 showed the least corrosion rate with an increase after 360<sup>th</sup> hours. Both samples in pH 2 and pH 4 behaved alike with Sinusoidal increase and decrease and pH 4 nearly maintained its values until the last day. Formation of protective oxide film and dilution of the environment by the corrosion products were observed to reduce corrosion rates in the investigated environment.
