EM Interference on 24” Subsea Pipeline Due To Piggybacking of 33kv Cable

Abstract - EM Interference due to a transmission line or cable having common right of way with a metallic utility can cause serious damage to the utility structure or the public in close vicinity. This paper describes a similar case study where EM effects are studied due to a 33kV subsea cable sharing common right of way with a 24” subsea pipeline. The study has been performed to analyze the typical hazards on pipeline integrity as well as human safety. CDEGS software has been utilized for the study and necessary mitigation measures have been worked out.

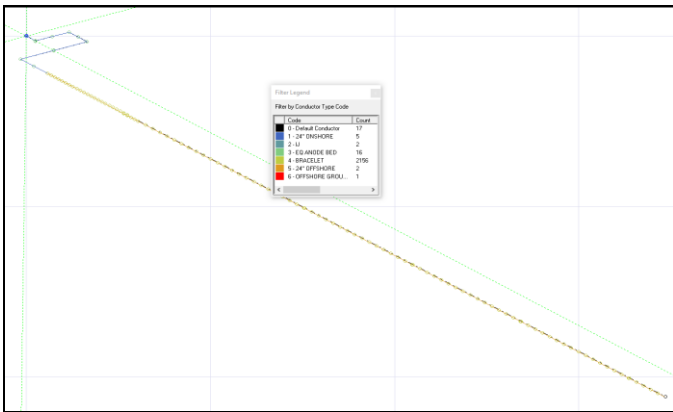
System has been modelled in SESCAD tool used for 3D modelling of arbitrary system. Below

Figure 2 – 33kV cable and 24” pipeline system

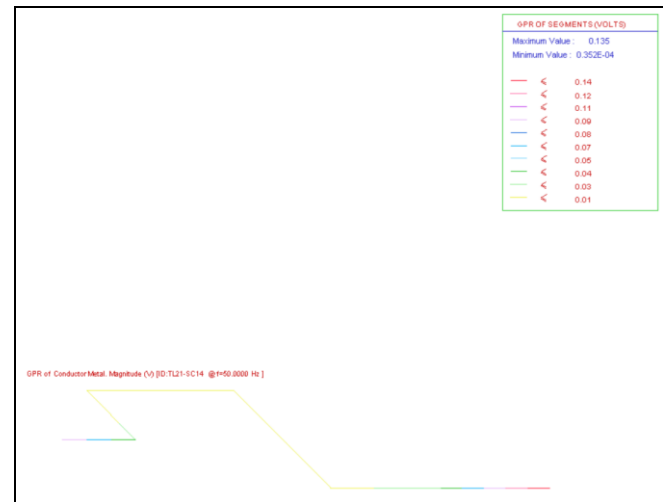
Figure 4 – Induced Voltage (GPR) in Onshore Section of Pipeline

Onshore Section Induced Voltage (volts)	Offshore Section Induced Voltage (volts)	Max. Touch Voltage (volts)
0.135	1.177	3.254

From the results, it is identified that the cable peak loading current of 400 amps is significant to induce the GPR of 1.177 volts in the offshore section of pipeline. This induced EMF is significant enough to cause accelerated AC corrosion currents on the pipeline. The calculation of this AC corrosion currents leaving the pipeline from a 1 cm² holiday are based on below formula –

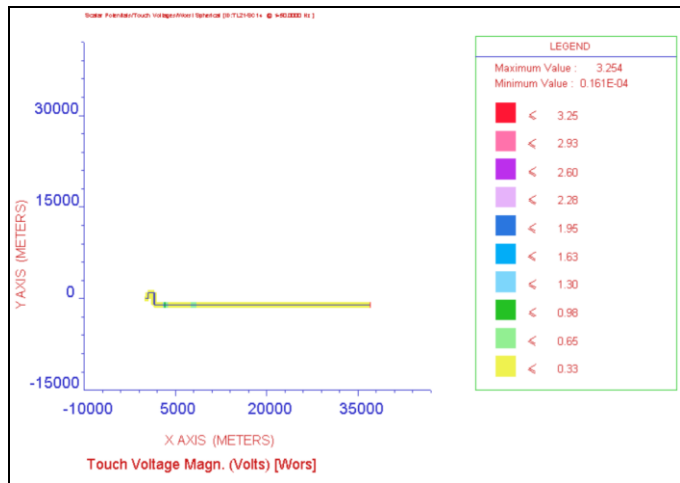
Figure 6 - Max. Touch Voltage at Pipeline Appurtenance

AC current leaking through 1 cm² coating holiday has been calculated as **264.8 A/m²**. As per NACE criteria, this AC leakage current is significant enough to cause accelerated corrosion on pipeline. Whereas pipe touch voltage and step voltages at the appurtenance are none of a concern as the GPR due to induced potentials on the pipeline itself is 1.2 volts. This pipeline GPR of 1.2 volts is well within the permissible limit of 15V during normal operating conditions.

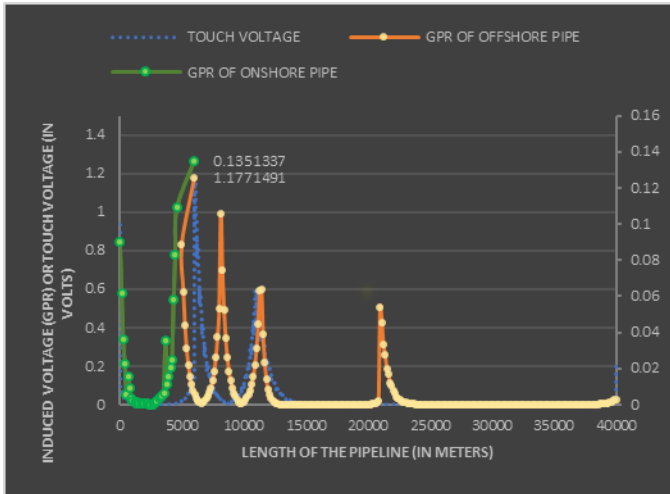
NOTE – Blue and orange trend is not continuous in the plot as Onshore and Offshore sections are separated by insulating joint.

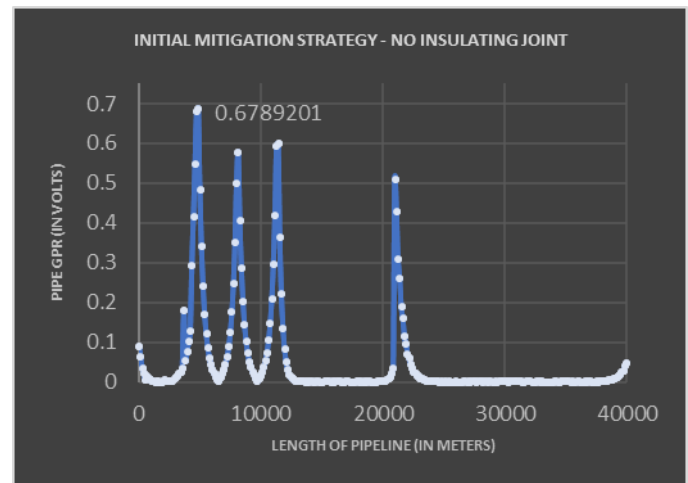
Figure 7 – Induced Voltage (GPR) in Pipeline after Removing Insulating Joint

From **Figure 7** above, it is observed that after removing insulating joint the overall induced voltage (GPR) has been distributed which lowers the overall GPR value on the pipeline from max. 1.177 volts to 0.68 volts. The GPR of 0.68 volts is seen on the offshore buried pipeline. This GPR value is still higher when analyzed from the corrosion point of view as the AC corrosion current density calculated through a 1 cm² holiday equal to **154.8 A/m²** which is still much higher than the permissible value as per NACE standard. Hence, this strategy has not been analyzed further.

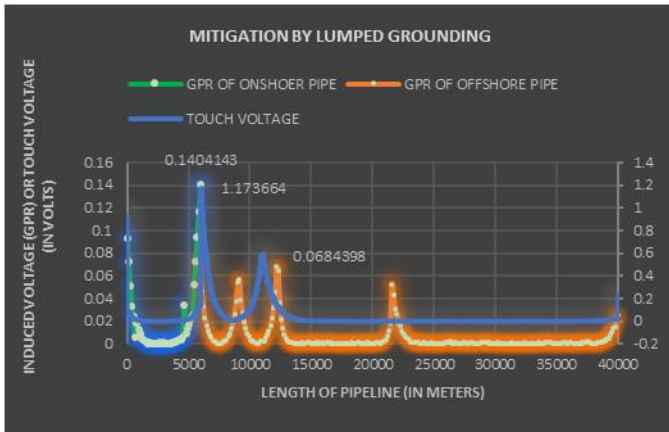
Onshore Section Induced Voltage (volts)	Offshore Section Induced Voltage (volts)	Max. Touch Voltage (volts)
0.140	0.068	1.173

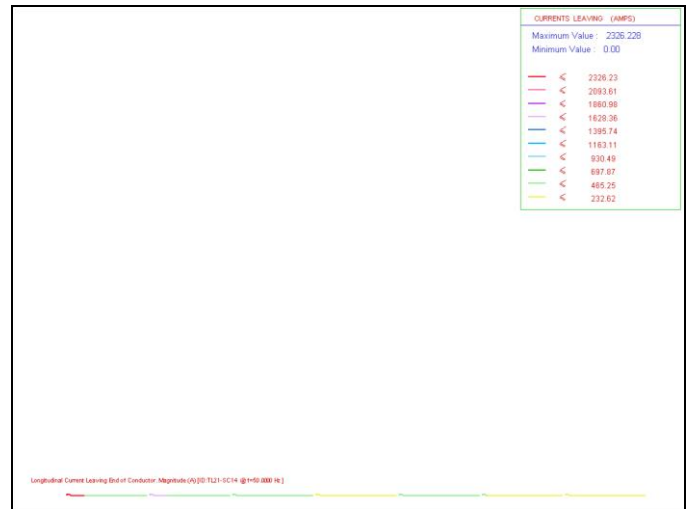
The mitigation design has been further studied for fault condition where Line to Ground and 3 Phase fault has been performed at the end of 33kV cable piggybacking the 24” pipeline. Line to Ground fault has been simulated by shorting the cable core 1 with sheath 1 while the fault current is 2.3 kA in the cable core. Similarly, 3 Phase fault has been simulated by shorting the 3 cores at the end of piggyback of 33kV while the fault current is 4.3 kA in the cable cores.

Figure 11 - LG Fault Current in Cable Core 1 & Sheath 1 Component

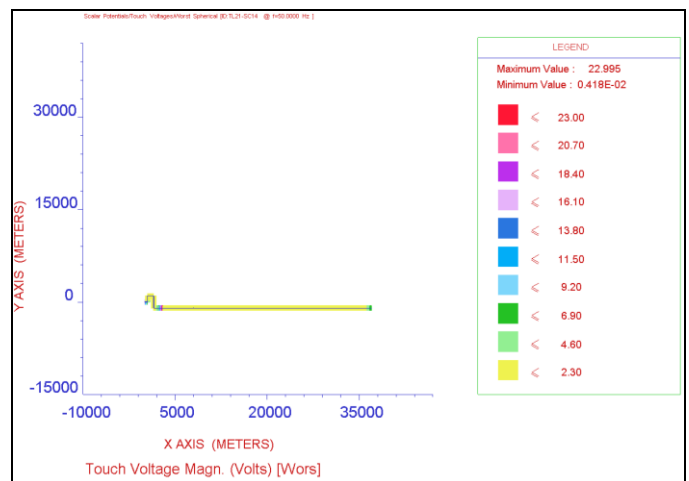
Figure 12 – Max. Touch Voltage at Pipeline Appurtenance

Computed Value	Permissible Value
Coating Stress Voltage (volts)	21.998	3000
Max. Touch Voltage (volts)	22.995	252.2

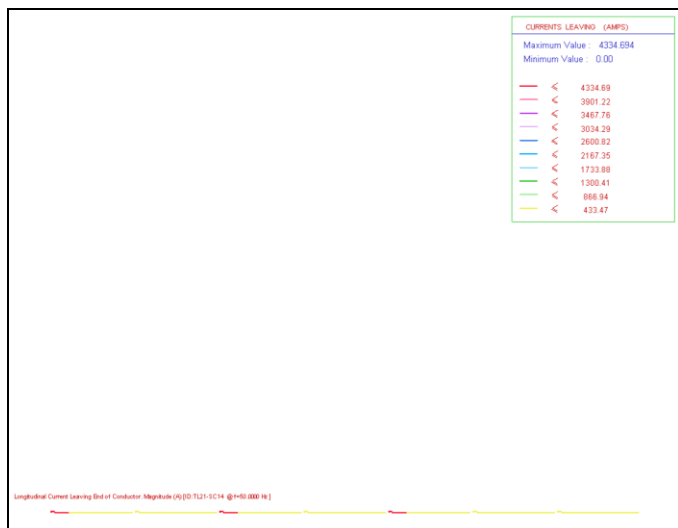
Figure 14 - LLL Fault Current in Cable Core 1 & Sheath 1 Component

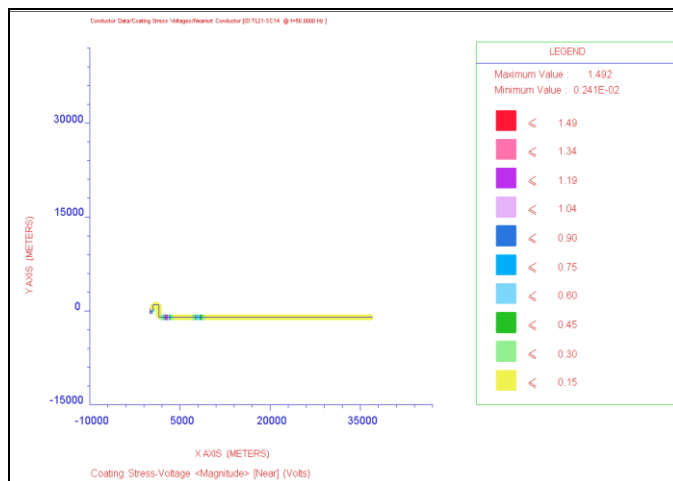
Figure 16 - Coating Stress Voltage on the Pipeline during LG Fault on 33 kV Cable

Computed Value	Permissible Value
Coating Stress Voltage (volts)	1.492	3000
Max. Touch Voltage (volts)	1.536	252.2
