Evaluation of Shear Strength Parameters for Design of Dam for a Drinking Water Project-A Case Study

Central Soil and Materials Research Station
Olof Palme Marg, Hauz Khas, New Delhi-110016

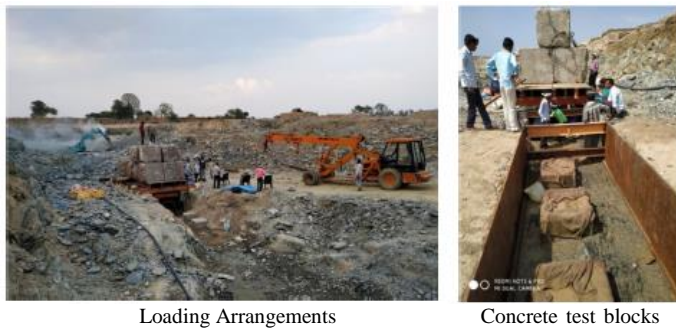
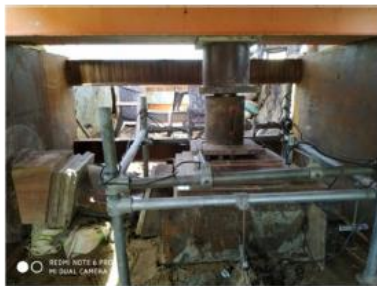
Fig. 3: Glimpse of testing in an open trench

Testing on concrete to rock interface

Six numbers of shear tests were conducted on concrete-rock interface. Blocks were prepared using M20 grade concrete on chiselled smooth surface of rock mass in accordance with provisions contained in [5] and [6] in the open trench at dam spillway section at different RD's on fine grained, dark grey coloured, vertical to sub-vertical, dipping upstream side phyllite rock mass. These tests were conducted at normal loads of 10T, 15T, 20T, 25T, 30T and 35T. The range of normal loads has been chosen based on proposed height of the dam. Some of the photographs of the in-situ shear test are given in Fig. 3 [7].

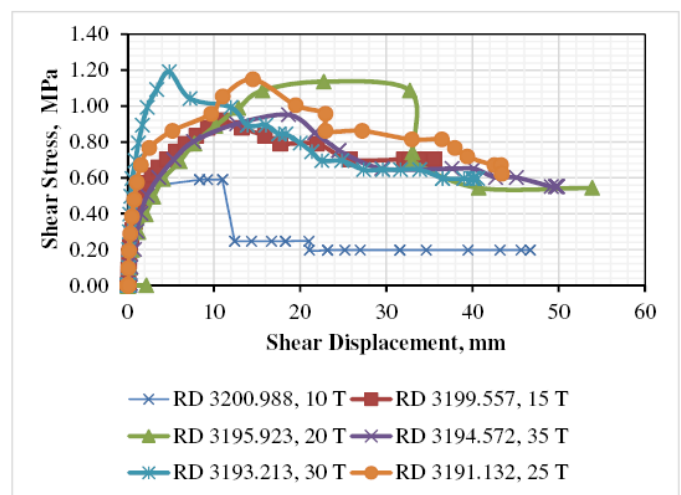
Fig. 4: Plot of Shear Stress and Shear Displacements

curve fitting is drawn using linear regression analysis. Intercept of trend line on Y-axis gives cohesion 'c' and slope of the line gives friction angle 'φ' of rock mass. The test results are given in Table 1. Shear stress - shear displacement data at different normal loading are plotted in Fig. 4.

Theoretically, as the value of normal stress increases shear stress should also increase. This is not possible in real conditions due to progressive failure, complex pattern of joints and formation of key etc. while shearing the blocks at different locations. Pattern and properties of rock mass discontinuities is the main reason for scattered data. From Fig. 4, it could be seen that test results at 15T normal load is nearly matching with that of blocks tests at normal loads of 25T and 35T. Further, on overturning the blocks, formation of rock key in the direction of shear was observed in DST-2 tested at 15T normal load, thus providing additional resistance to shearing. The formation of such key could not be observed in other tests. Therefore, test results of block tested at 15T normal load have been omitted for linear fitting of data for determining shear strength parameters.
