## Failure Analysis Of Exhaust Valve Spring Of C.I.Engine

### Abstract

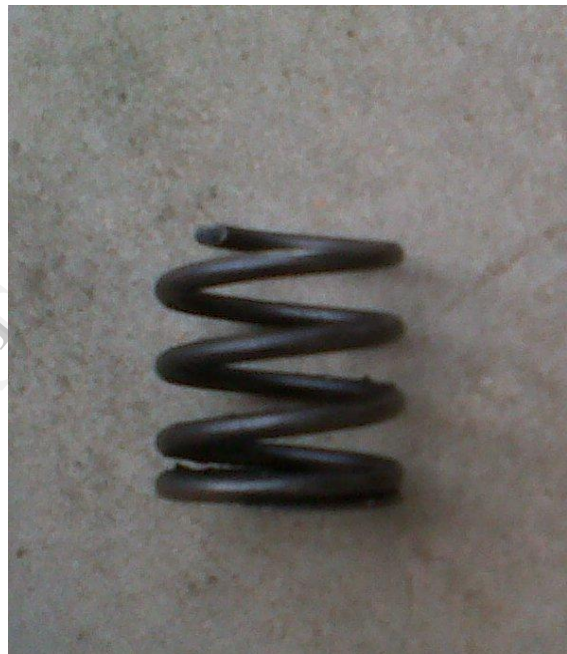
Fig-1. Failed spring

The spring was designed for 1500 rpm diesel engine and now used in 2200 rpm diesel engine. The failure occurs with 2200 rpm engine, with similar pattern ie. at 1.5 to 2 turns as shown in fig 1. There may be one or more reasons for exhaust valve spring failure. Some of these reasons are due to improper metallurgical properties of spring, improper design etc. The effects of this failure results in deterioration of engine performance (brake power & efficiency), failure

The spring was designed for 1500 rpm diesel engine and now used in 2200 rpm diesel engine. The failure occurs with 2200 rpm engine, with similar pattern ie. at 1.5 to 2 turns. There may be one or more reasons for exhaust valve spring failure. Some of these reasons are due to improper metallurgical properties of spring, improper design etc. The effects of this failure results in deterioration of engine performance (brake power & efficiency), failure of other components eg. cylinder head, valve guide, wear in between valve and cylinder head.

redesigning the spring. The length of the spring should be kept same so that the other parts can be used without alterations. The new spring is designed by increasing the wire diameter to 3mm from 2.6mm and decreasing the number of coils to 5.5 turns from 6.5 turns. In this spring the stress value will decrease and the reaction force in spring will increase.

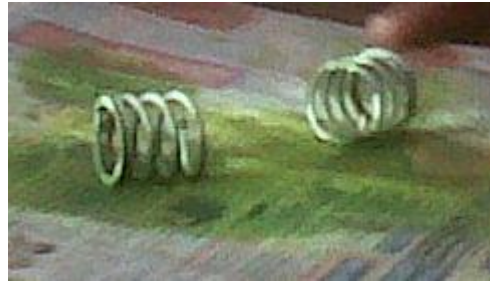
Fig-3 die penetration test

The Die-penetration test is done to see the minor cracks or flaws on the surface. In this test spring surface is first cleaned chemically, after 5-7 min fluorescent colour is sprayed on the surface, then for 10-15 min the surface is kept for drying and then after developer is applied. Now clean the spring with tissue paper and the micro cracks or flows are seen to be glowing under ultraviolet light. The surface is observed generally smooth.
