Integrated Studies on Tank Catchment Management Using Remote Sensing and Geographical Information System

(A case study for Byramangala tank catchment, Ramanagaram district, Karnataka, India)

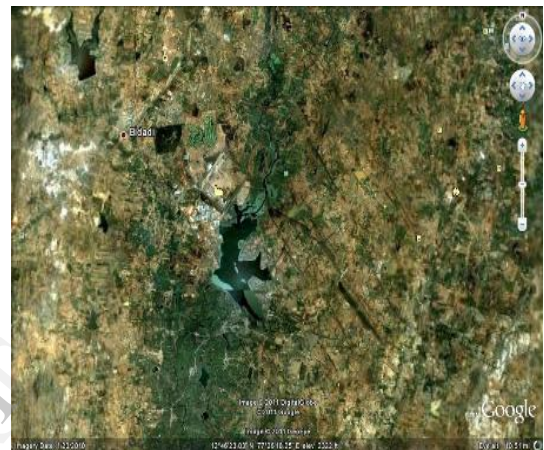
Fig 1 Satellite image of Byramangala tank

Byramangala tank is located in Bidadi hobli of Ramanagaram district. The catchment area includes Bangalore urban areas which comes under Bhruhauth Bangalore Mahanagara Palike and villages of Bangalore rural area, Rajajinagar Industrial area, Peenya Industrial area and Kumbalgor Industrial area and the Bidadi Industrial are located in this tank catchment area. The Vrishabhavathi river which runs in the catchment, carries urban /domestic sewage, industrial sewage and storm water from urban, semiurban and rural areas. The agricultural wastes resulting from intensive farming in the rural areas of the catchment also enter the tank. The study reveals that the tank is highly polluted and the sediments are also contaminated. The annual rainfall data of 789mm and average monsoon rainfall of 551mm were collected from the records of the rain gauge installed at Byramangala. The minimum annual inflow to the tank is $23.92M^3$ and maximum annual inflow is $114.5 \times 10^9 M^3$. The withdrawal from canal is recorded as $34.97M^3$ cum and the reservoir losses are noted up to $5.42M^3$. The details of tank indicated FRL as $24.10Mm^3$, live storage at FRL as $22.01Mm^3$, dead storage at sill level of sluice as $2.09Mm^3$ and water spread area at FRL as 430.25ha. The spillway of tank is of broad crested type located at right flank. The length of spillway is of 150.5m, its flood lift is recorded as 0.9m and discharge capacity is of 230cumecs. The bund constructed for Byramangala tank is of earthen type and its height at the deepest point is recorded as 22.85m. The length of the bund is recorded as 2286m and top width of the bund as 3.66m.

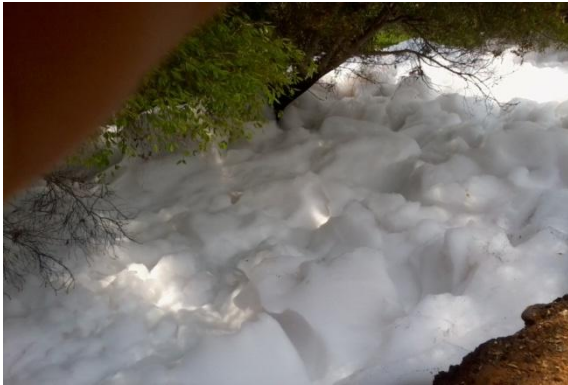
Fig 2 Polluted water flowing through the left bank canal
Studies on Geology and Geomorphology of the study area

The MWL of the tank is noted as 32.9m its FRL as 32m and its sill level as 22.85m. The Reservoir is provided with 2 channels, viz., Left Bank canal and Right bank canal. The left bank canal is 26.4 km in length and Right bank canal is 8.4 km in length having a command area of 1330 ha and right bank canal is 8.4 km having a command area of 444ha. Reconnaissance survey reveals that the soil in the command area is polluted with the application of sewage water.

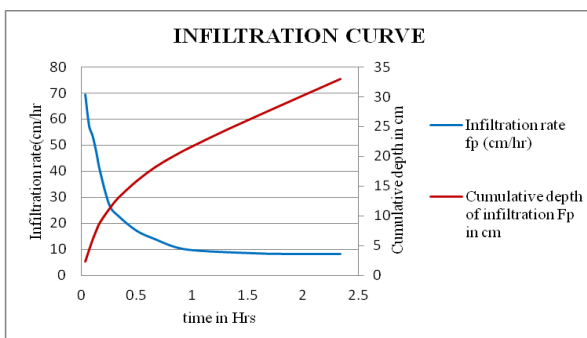
Fig 7 Infiltration Rate curve for Kodiyal Karenahalli

| Sl no | Location | Horton's equation |
|---|---|---|
| 1 | Kodial Karenahalli | $F = 8.28 + 76.709 e^{-17.762t}$ |
