Retrofit Study of Existing Bridge with Girders in Vore Railway Overpass

Abstract— This paper presents a case study of superstructure retrofitting with girders on Vore railway overpass, Albania. This study aims of providing an overview on assessment of existing structure based on original project, comparing models of traffic loads under existing code in our country with standart Eurocode traffic loading. Superstructure is all precast with total length $L=313.24$ m .The existing overpass was constructed and built approximately 25 years ago. It is located in a national axis with a significant movement of vehicle flows which has been increasing nowadays .Overloading due to increase in wheel loads and exposure to environment lead to degradation of overpass structure. Poor quality of construction and lack of regular maintenance lead to major retrofit in the overpass structure. Assessment analysis determine that superstructure should be retrofitted. The general approach to retrofitting superstructure is to increase the shear or flexural strength of the girders and deck, to carry standart Eurocode traffic loading . Concrete jacketing have been used for external strengthening of concrete s

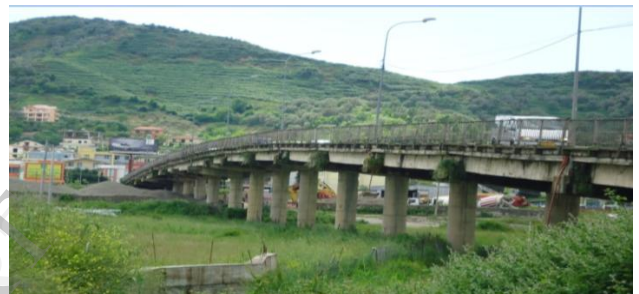
Fig. 1. General view of Vora brigde

The railway overpass is located on national road axis Vore - Lac, in the triangle of Vora railway overpass, with a total length $L = 313.24$ m. Existing overpass was built in 1989. It consists of 19 light space with span up $HD = 15$ m. Superstructure is consists of simply supported girders on each side and is all precast. In recent years, increasing the flow of vehicles along with the degradation have been damage the superstructure. Its degradation is a major problem and brings the necessity of the structure rehabilitation. Damage of bridges superstructure is usually as a result of corrosion and increased traffic load in recent decades. The construction is designed for highway normative loads of albanian codes N-18; T-80. Gauge $G-7 + (2 + 1)$ m for sidewalks. Modeling the structure with finite elements method FEM using existing project, Eurocodes standart made it possible to determine the strain in positions where we care. The primary function of superstructure is to support the vehicular vertical loads and to distribute these loads to the substructure. The purpose of the study is to increase the carrying capacity of superstructure

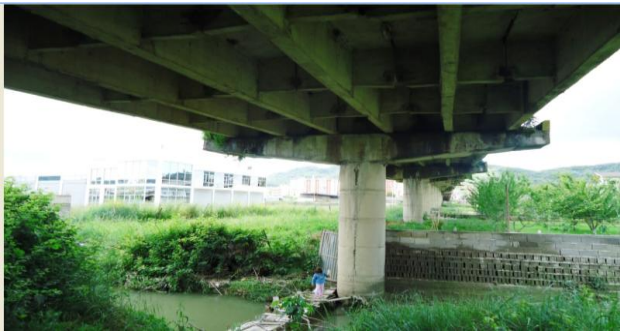
Fig. 2. Overview of girders superstructure

1. From carefully inspection are observed visible cracks on beams and decks.
2. Detachment of concrete cover.
3. Corrosion and reduction of cross section rebar.
4. Quality and strength of concrete is low.
5. Spalling .
6. Paint is in poor condition and lead based.

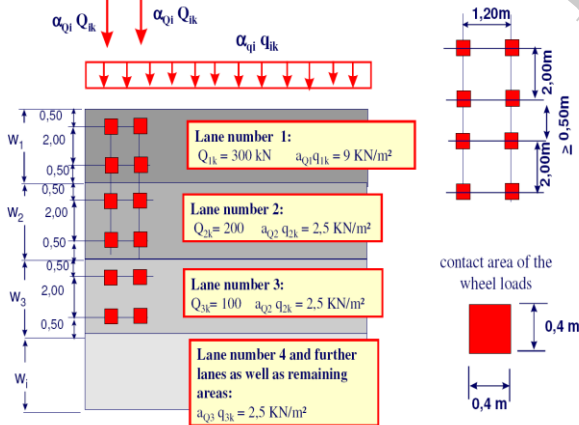
Fig. 4. Schematic view of load traffic model LM1

Concentrated and distributed loads (main model – For general and local verifications)¹

- Assessment of existing structure be realized based on original project, on site investigation.
- Analysis of two model: First model, capacity assessment of superstructure with Albanian technical conditions of vehicle loads N-300 and K-800. Second model, capacity assessment with european normative traffic loads model for road bridges LM1. Interpretation of the result and problem identification.
