Analysis of Failed Teton Dam

Abstract—The failure of Teton Dam in Idaho in June, 1976, during the first filling of the reservoir, was a significant event for geotechnical engineers concerned with the design and construction of earth dams, simply because no dam of such a height (approximately 300 ft above stream bed) had previously failed. Thus the failure was both dramatic and of considerable importance. This paper reviews the events leading to the failure of Teton Dam to determine the cause of failure. Conclusions are presented regarding the probable trigger mechanisms which initiated the failure. In addition, an investigation of the area by geologist of the U.S. Geologic Survey indicated that it was seismically active: five earthquakes had occurred within 30 miles (50 km) of the dam site in the previous five years, two of which had been of significant magnitude. As it was a finite slope structure which failed during the first filling of the reservoir, therefore, in order to review the causes of failure, slope stability analysis of this dam profile has been done under structural stability, seepage and seismic analysis. The aforesaid analyses are accomplished using several methods

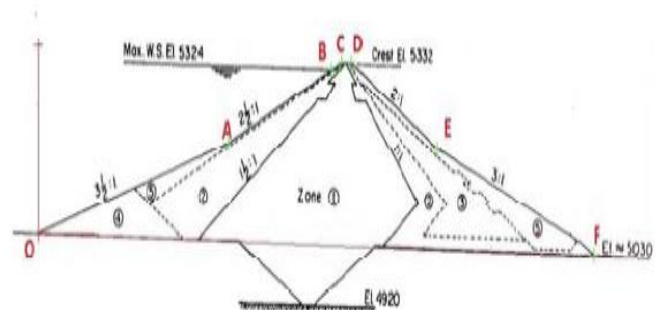
Figure 5: Discretization of the Teton dam.

The coordinates of different points of profile along X-axis and Y-axis is digitalized using the "Digitizeit" software as shown in figure 5.
