Urea Stripper Tube Leakage

Prem Baboo

National Fertilizers Ltd. India

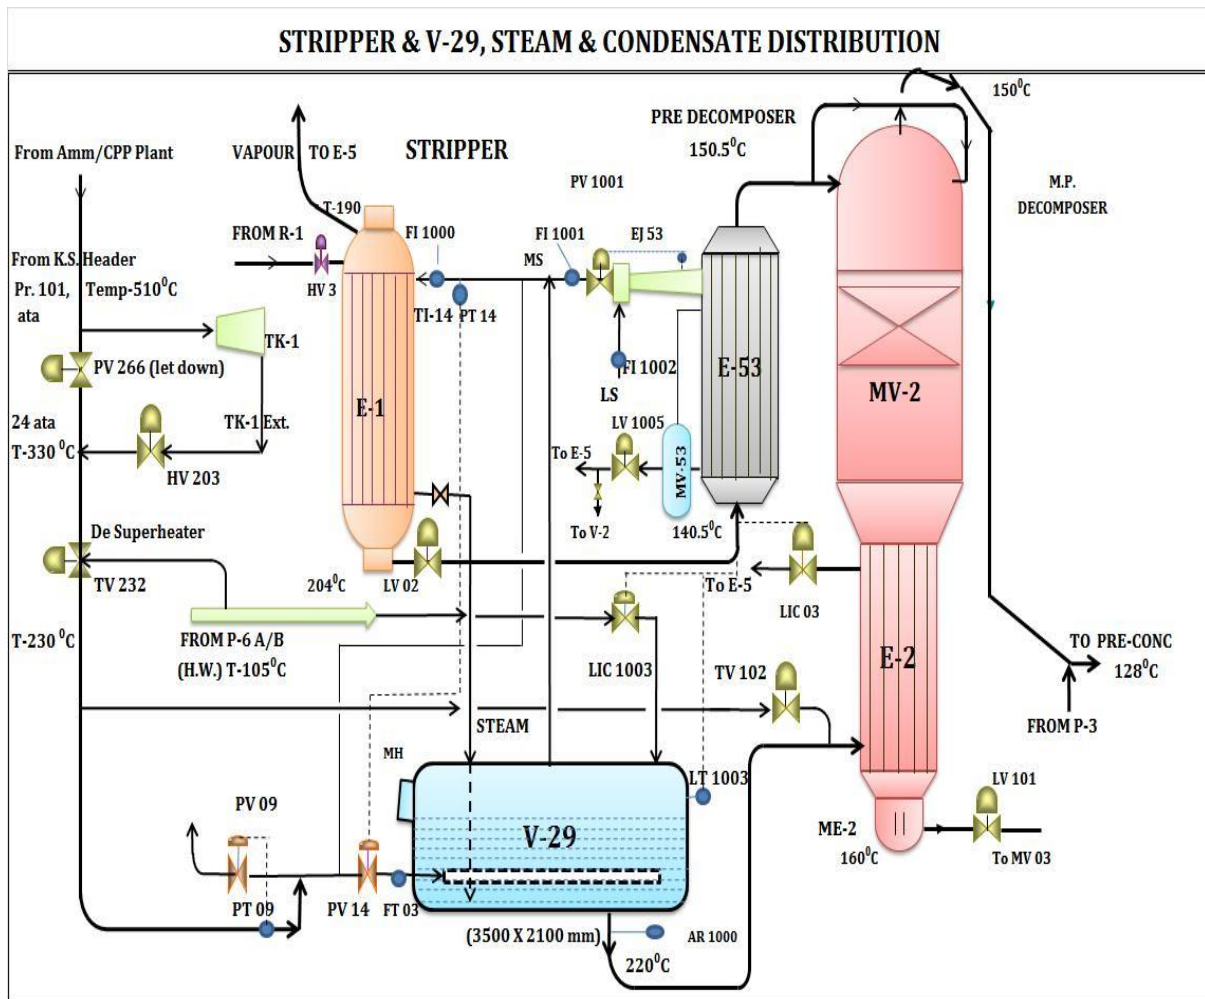
Fig-3

An ammonia rich gas (CO₂ lean gas) rises from lower parts of the tube, then the gas at the upper parts of the tube becomes an ammonia richer gas as compared with equilibrium composition and the decomposition reaction in liquid phase correct the deviation from the equilibrium (the stripping effect). Carbamate is decomposed at reactor pressure with the help of one of the reactants. First thing that comes into mind while going to look for leakage in such high pressure vessel is that, what are the potential points that can lead to leakage in such thick metal walls. There are three surfaces in contact with highly corrosive Carbamate solution.
